# Access Compliance Report

## Public Rights-of-Way

### (Curb Ramps)

Intersection ID: 15545	Main Street: ELMHURST_RD	Cross Street: POINDEXTER_DR	Location: S
ADA ID: 74DA2393FA91	Ramp Type: PerpDiag	Initial Pass/Fail: Fail	Overall Compliance: No
		Severity Score: 37.5

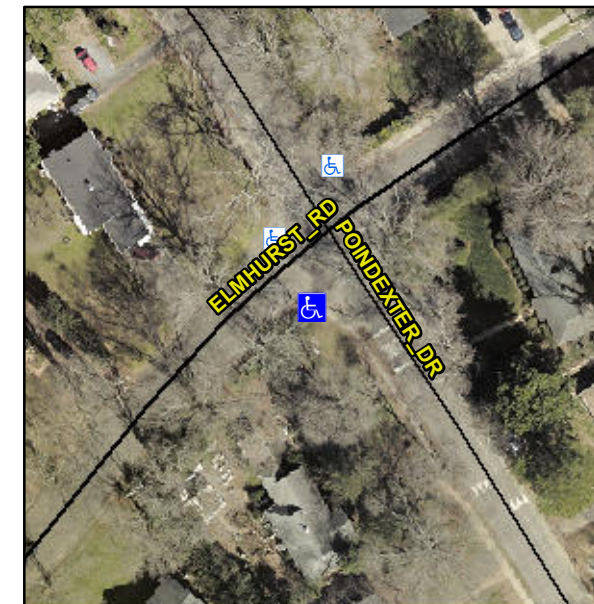
Compliance	Description	Data	Compliance	Description	Data
N/A	Ramp Length (in)	69.0	No	Ramp Slope (%)	15.5
Yes	Ramp Width (in)	48.0	No	Ramp XSlope (%)	5.2
N/A	Flare Type LT	N/A	N/A	Flare Type RT	N/A
N/A	Flare Slope LT (%)	N/A	N/A	Flare Slope RT (%)	N/A
N/A	Flare Traversable LT?	N/A	N/A	Flare Traversable RT?	N/A
N/A	Landing Length (in)	N/A	N/A	DWS Provided?	N/A
N/A	Landing Width (in)	N/A	N/A	DWS Contrast?	N/A
N/A	Landing Slope (%)	N/A	N/A	DWS Length (in)	N/A
N/A	Landing X Slope (%)	N/A	N/A	DWS Full Width?	N/A
N/A	Landing Curb? (Y/N)	N/A	N/A	DWS Offset (in)	N/A
N/A	Shared Landing?	N/A			
N/A	Gutter Ponding?	N/A	N/A	Gutter Slope (%)	N/A
N/A	Gutter Lip Ht (in)	1.0	N/A	Gutter X Slope (%)	N/A
N/A	Painted X Walk1?	No	N/A	Painted X Walk2?	No
	X Walk 1 Direction	To NE		X Walk 2 Direction	To N
N/A	X Walk 1 Width (in)	N/A	N/A	X Walk 2 Width (in)	N/A
	X Walk 1 Slope (%)	2.8		X Walk 2 Slope (%)	0.9
	X Walk 1 X Slope (%)	0.2		X Walk 2 X Slope (%)	3.5

N/A	Ramp inside XWalk1?	N/A	N/A	Ramp inside XWalk2?	N/A
	Road Slope (%)	2.3	N/A	Clear Space?	N/A
	Road X Slope (%)	2.3	N/A	Clear Space to XWalk (in)	N/A
N/A	Any Obstructions?	N/A	N/A	Storm Grate/Utility Hazard?	N/A
	Obstruction Type			Storm Grate/Utility Type	
		N/A			N/A
			Yes	Surface Condition? (G/P)	Good

**Remove & Replace Curb Ramp With Two New Directional Ramps or Equivalent.**
