Access Compliance Report

Public Rights-of-Way

(Curb Ramps)

Intersection ID: 23929	Main Street: BROADWATER_LN	Cross Street: STEPHENDALE_DR	Location: NE
ADA ID: 74F91AAB1D2C	Ramp Type: PerpDiag	Initial Pass/Fail: Fail	Overall Compliance: No
Severity Score: 30			
Codes/Mitigation Info/Possible Solution		Field Measurements/Component Compliance

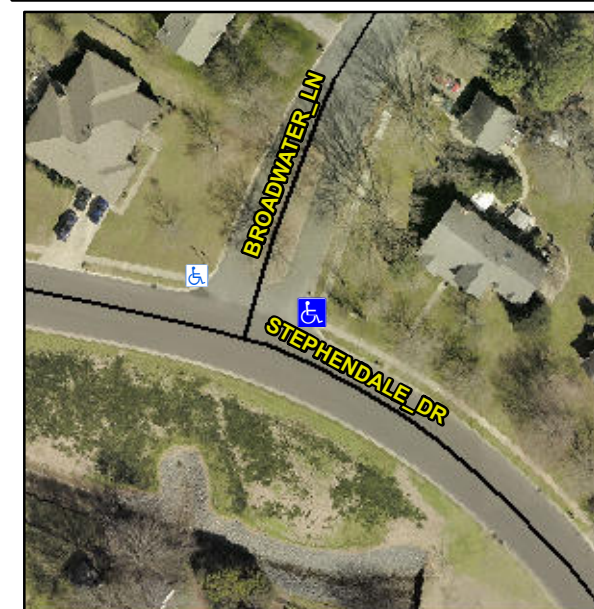
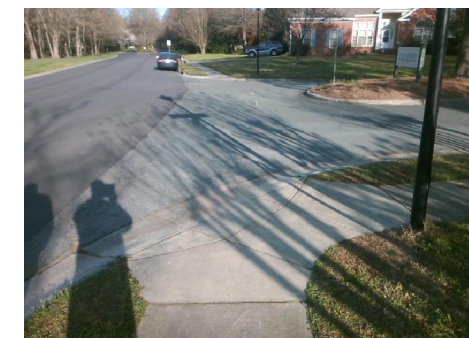
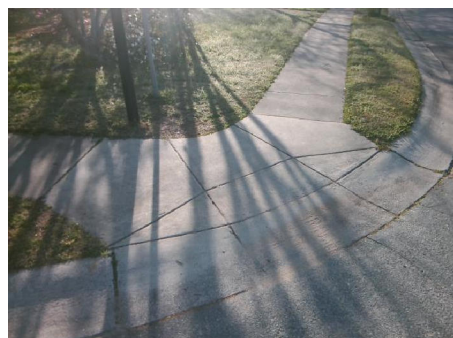
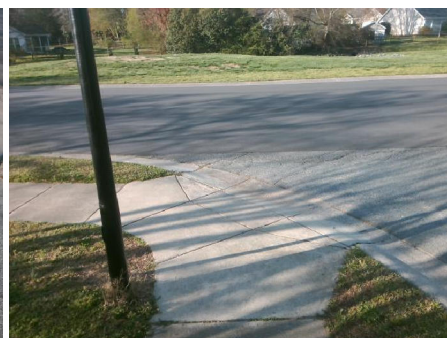
Not Found, R304.5.1, R304.2.2

Compliance	Description	Data	Compliance	Description	Data
N/A	Ramp Length (in)	59.0	No	Ramp Slope (%)	10.3
No	Ramp Width (in)	34.0	Yes	Ramp XSlope (%)	0.4
N/A	Flare Type LT	N/A	N/A	Flare Type RT	N/A
N/A	Flare Slope LT (%)	N/A	N/A	Flare Slope RT (%)	N/A
N/A	Flare Traversable LT?	N/A	N/A	Flare Traversable RT?	N/A
N/A	Landing Length (in)	N/A	N/A	DWS Provided?	N/A
N/A	Landing Width (in)	N/A	N/A	DWS Contrast?	N/A
N/A	Landing Slope (%)	N/A	N/A	DWS Length (in)	N/A
N/A	Landing X Slope (%)	N/A	N/A	DWS Full Width?	N/A
N/A	Landing Curb? (Y/N)	N/A	N/A	DWS Offset (in)	N/A
N/A	Shared Landing?	N/A			
N/A	Gutter Ponding?	N/A	N/A	Gutter Slope (%)	N/A
N/A	Gutter Lip Ht (in)	N/A	N/A	Gutter X Slope (%)	N/A
N/A	Painted X Walk1?	No	N/A	Painted X Walk2?	No
	X Walk 1 Direction	To NW		X Walk 2 Direction	To SW
N/A	X Walk 1 Width (in)	N/A	N/A	X Walk 2 Width (in)	N/A
	X Walk 1 Slope (%)	1.6		X Walk 2 Slope (%)	3.4
	X Walk 1 X Slope (%)	1.6		X Walk 2 X Slope (%)	2.0

N/A	Ramp inside XWalk1?	N/A	N/A	Ramp inside XWalk2?	N/A
	Road Slope (%)	0.4	N/A	Clear Space?	N/A
	Road X Slope (%)	4.4	N/A	Clear Space to XWalk (in)	N/A
N/A	Any Obstructions?	N/A	N/A	Storm Grate/Utility Hazard?	N/A
	Obstruction Type			Storm Grate/Utility Type	
		N/A			N/A
		Yes		Surface Condition? (G/P)	Good

Remove & Replace Curb Ramp With Two New Directional Ramps or Equivalent.

Total Cost: \$ 3200.00
