Intersection ID: 27701	Main Street: HEADFORD_RD	Cross Street: LEITRIM_CT	Location:	SE
ADA ID: 75035ACA5839	Ramp Type: BlendTrans1	Initial Pass/Fail: Fail	Overall Compliance: No	Severity Score: 8.75

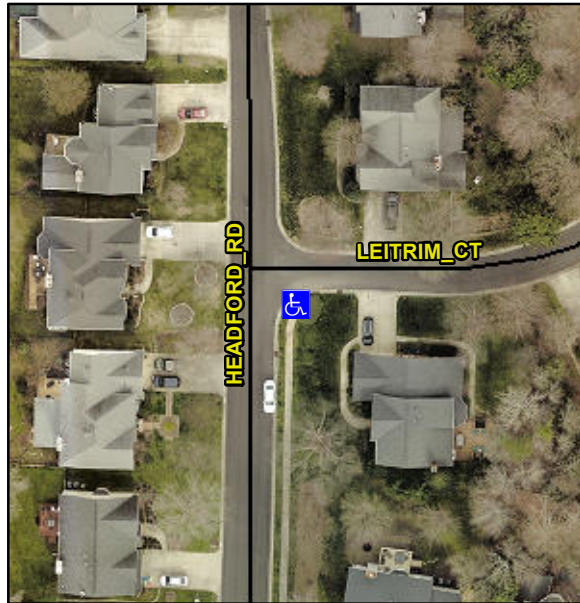
Possible Solutions:		Compliance	Description	Data	Compliance	Description	Data
Remove & Replace Curb Ramp With Two New Directional Ramps or Equivalent.	N/A	Ramp Length (in)	53.0	Yes	BlendTrans Slope (%)	4.2	
	No	Ramp Width (in)	41.0	Yes	BlendTrans XSlope (%)	0.2	
	N/A	Flare Type LT	N/A	N/A	Flare Type RT	N/A	
	N/A	Flare Slope LT (%)	N/A	N/A	Flare Slope RT (%)	N/A	
	N/A	Flare Traversable LT?	N/A	N/A	Flare Traversable RT?	N/A	
	N/A	Landing Length (in)	N/A	N/A	DWS Provided?	N/A	
	N/A	Landing Width (in)	N/A	N/A	DWS Contrast?	N/A	
	N/A	Landing Slope (%)	N/A	N/A	DWS Length (in)	N/A	
	N/A	Landing X Slope (%)	N/A	N/A	DWS Full Width?	N/A	
	N/A	Landing Curb? (Y/N)	N/A	N/A	DWS Offset (in)	N/A	
Surveyor Notes: N/A	N/A	Shared Landing?	N/A				
	N/A	Gutter Ponding?	N/A	N/A	Gutter Slope (%)	N/A	
	N/A	Gutter Lip Ht (in)	N/A	N/A	Gutter X Slope (%)	N/A	
	N/A	Painted X Walk1?	No	N/A	Painted X Walk2?	No	
		X Walk 1 Direction	To N		X Walk 2 Direction	To W

X Walk 1 Width (in)	N/A		X Walk 2 Width (in)	N/A	
		X Walk 1 Slope (%)	0.4		X Walk 2 Slope (%)	0.1	
		X Walk 1 X Slope (%)	0.5		X Walk 2 X Slope (%)	2.0	
	N/A	Ramp inside XWalk1?	N/A	N/A	Ramp inside XWalk2?	N/A	
		Road Slope (%)	0.4		Clear Space?	N/A	
PROW/ADA: Not Found, R304.5.1		Road X Slope (%)	0.7	N/A	Clear Space to XWalk (in)	N/A	
	N/A	Any Obstructions?	N/A	N/A	Storm Grate/Utility Hazard?	N/A	
		Obstruction Type			Storm Grate/Utility Type		
			N/A			N/A	
				Yes	Surface Condition? (G/P)	Good	
				No	Curb Slope (%)	12.9	
	Total Cost:	\$	3200.00

Remove & Replace Curb Ramp With Two New Directional Ramps or Equivalent.
