Access Compliance Report

Public Rights-of-Way

(Curb Ramps)

Intersection ID: 31427	Main Street: CHEVIOTT_HILL_LN	Cross Street: RIDING_HILL_AV	Location: E
ADA ID: 751FCCD0FD36	Ramp Type: PerpDiag	Initial Pass/Fail: Fail	Overall Compliance: No
			Severity Score: 21.25

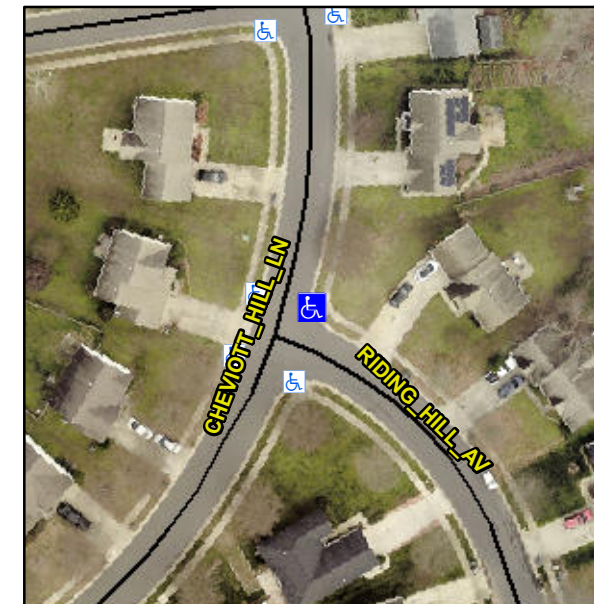
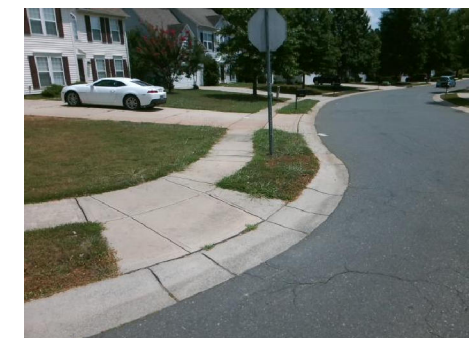
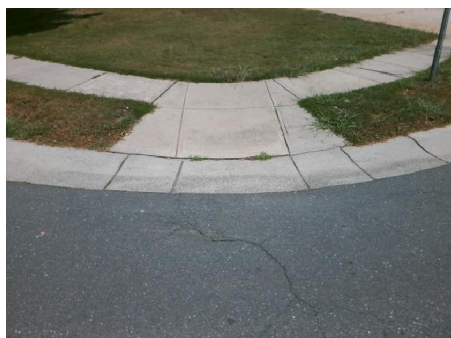
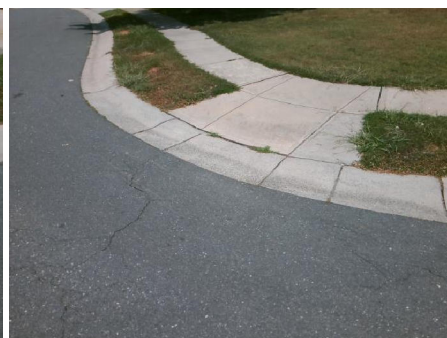
Not Found, R304.5.1, R304.2.2

Compliance	Description	Data	Compliance	Description	Data
N/A	Ramp Length (in)	48.0	No	Ramp Slope (%)	8.9
No	Ramp Width (in)	47.0	Yes	Ramp XSlope (%)	1.1
N/A	Flare Type LT	N/A	N/A	Flare Type RT	N/A
N/A	Flare Slope LT (%)	N/A	N/A	Flare Slope RT (%)	N/A
N/A	Flare Traversable LT?	N/A	N/A	Flare Traversable RT?	N/A
N/A	Landing Length (in)	N/A	N/A	DWS Provided?	N/A
N/A	Landing Width (in)	N/A	N/A	DWS Contrast?	N/A
N/A	Landing Slope (%)	N/A	N/A	DWS Length (in)	N/A
N/A	Landing X Slope (%)	N/A	N/A	DWS Full Width?	N/A
N/A	Landing Curb? (Y/N)	N/A	N/A	DWS Offset (in)	N/A
N/A	Shared Landing?	N/A			
N/A	Gutter Ponding?	N/A	N/A	Gutter Slope (%)	N/A
N/A	Gutter Lip Ht (in)	N/A	N/A	Gutter X Slope (%)	N/A
N/A	Painted X Walk1?	No	N/A	Painted X Walk2?	No
	X Walk 1 Direction	To NW		X Walk 2 Direction	To SW
N/A	X Walk 1 Width (in)	N/A	N/A	X Walk 2 Width (in)	N/A
	X Walk 1 Slope (%)	6.7		X Walk 2 Slope (%)	4.8
	X Walk 1 X Slope (%)	1.2		X Walk 2 X Slope (%)	2.2

N/A	Ramp inside XWalk1?	N/A	N/A	Ramp inside XWalk2?	N/A
	Road Slope (%)	7.0	N/A	Clear Space?	N/A
	Road X Slope (%)	8.4	N/A	Clear Space to XWalk (in)	N/A
N/A	Any Obstructions?	N/A	N/A	Storm Grate/Utility Hazard?	N/A
	Obstruction Type			Storm Grate/Utility Type	
		N/A			N/A
			Yes	Surface Condition? (G/P)	Good

Remove & Replace Curb Ramp With Two New Directional Ramps or Equivalent.
