Access Compliance Report

Public Rights-of-Way

(Curb Ramps)

Intersection ID: 51356	Main Street: BRENTMOOR_DR	Cross Street: PEARL_ST	Location: S
ADA ID: 7527B90944F8	Ramp Type: BlendTrans1	Initial Pass/Fail: Fail	Overall Compliance: No
		Severity Score: 10

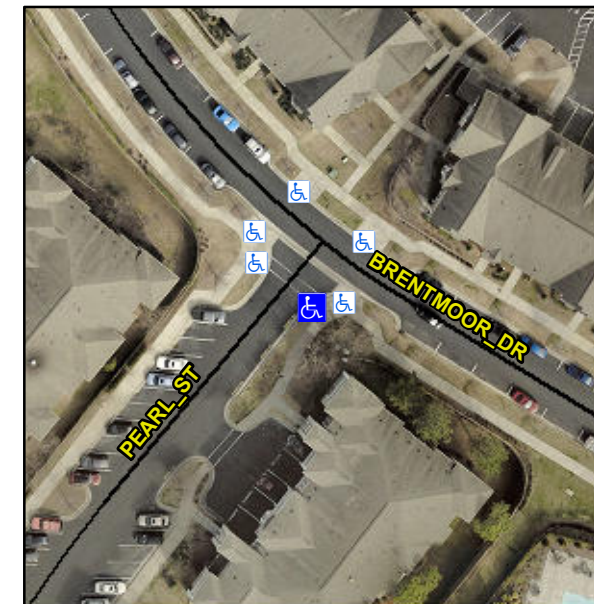
Not Found, R304.5.1, R304.5.3

Compliance	Description	Data	Compliance	Description	Data
N/A	Ramp Length (in)	75.0	Yes	BlendTrans Slope (%)	3.5
No	Ramp Width (in)	47.0	No	BlendTrans XSlope (%)	3.3
N/A	Flare Type LT	N/A	N/A	Flare Type RT	N/A
N/A	Flare Slope LT (%)	N/A	N/A	Flare Slope RT (%)	N/A
N/A	Flare Traversable LT?	N/A	N/A	Flare Traversable RT?	N/A
N/A	Landing Length (in)	N/A	N/A	DWS Provided?	N/A
N/A	Landing Width (in)	N/A	N/A	DWS Contrast?	N/A
N/A	Landing Slope (%)	N/A	N/A	DWS Length (in)	N/A
N/A	Landing X Slope (%)	N/A	N/A	DWS Full Width?	N/A
N/A	Landing Curb? (Y/N)	N/A	N/A	DWS Offset (in)	N/A
N/A	Shared Landing?	N/A			
N/A	Gutter Ponding?	N/A	N/A	Gutter Slope (%)	N/A
N/A	Gutter Lip Ht (in)	N/A	N/A	Gutter X Slope (%)	N/A
N/A	Painted X Walk1?	Yes	N/A	Painted X Walk2?	N/A
	X Walk 1 Direction	To NW		X Walk 2 Direction	N/A
	X Walk 1 Width (in)	65.0		X Walk 2 Width (in)	N/A
	X Walk 1 Slope (%)	7.5		X Walk 2 Slope (%)	N/A
	X Walk 1 X Slope (%)	1.2		X Walk 2 X Slope (%)	N/A

N/A	Ramp inside XWalk1?	Yes	N/A	Ramp inside XWalk2?	N/A
	Road Slope (%)	1.2		Clear Space?	N/A
	Road X Slope (%)	7.5	N/A	Clear Space to XWalk (in)	N/A
N/A	Any Obstructions?	N/A	N/A	Storm Grate/Utility Hazard?	N/A
	Obstruction Type			Storm Grate/Utility Type	
		N/A			N/A
			Yes	Surface Condition? (G/P)	Good
			No	Curb Slope (%)	13.1

Remove & Replace Curb Ramp With Two New Directional Ramps or Equivalent.
