Access Compliance Report

Public Rights-of-Way

(Curb Ramps)

Intersection ID: 27760	Main Street: BALLANTYNE_COUNTRY_CLUB_DR	Cross Street: BALLANTYNE_CROSSING_AV	Location: NE
ADA ID: 752DDFC81C35	Ramp Type: Perp	Initial Pass/Fail: Fail	Overall Compliance: No
Codes/Mitigation Info/Possible Solution			Severity Score: 10
Field Measurements/Component Compliance

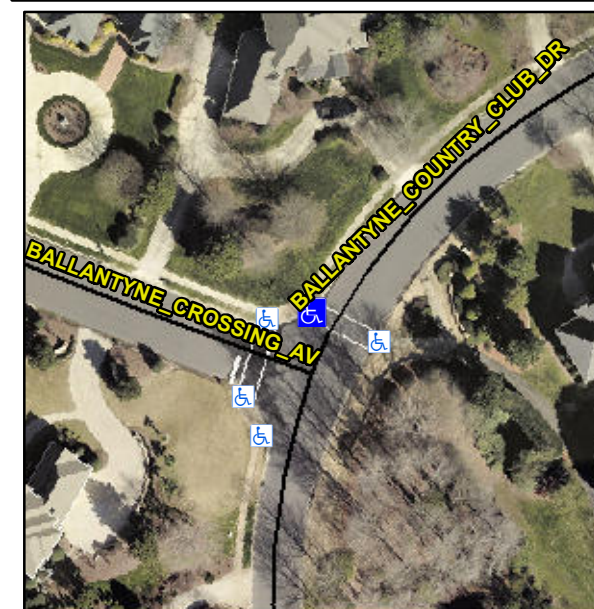
Not Found, R304.5.1

Compliance	Description	Data	Compliance	Description	Data
N/A	Ramp Length (in)	95.0	Yes	Ramp Slope (%)	6.2
No	Ramp Width (in)	44.0	Yes	Ramp XSlope (%)	3.3
N/A	Flare Type LT	N/A	N/A	Flare Type RT	N/A
N/A	Flare Slope LT (%)	N/A	N/A	Flare Slope RT (%)	N/A
N/A	Flare Traversable LT?	N/A	N/A	Flare Traversable RT?	N/A
N/A	Landing Length (in)	N/A	N/A	DWS Provided?	N/A
N/A	Landing Width (in)	N/A	N/A	DWS Contrast?	N/A
N/A	Landing Slope (%)	N/A	N/A	DWS Length (in)	N/A
N/A	Landing X Slope (%)	N/A	N/A	DWS Full Width?	N/A
N/A	Landing Curb? (Y/N)	N/A	N/A	DWS Offset (in)	N/A
N/A	Shared Landing?	N/A			
N/A	Gutter Ponding?	N/A	N/A	Gutter Slope (%)	N/A
N/A	Gutter Lip Ht (in)	N/A	N/A	Gutter X Slope (%)	N/A
N/A	Painted X Walk1?	Yes	N/A	Painted X Walk2?	N/A
	X Walk 1 Direction	To SE		X Walk 2 Direction	N/A
N/A	X Walk 1 Width (in)	105.0	N/A	X Walk 2 Width (in)	N/A
	X Walk 1 Slope (%)	5.6		X Walk 2 Slope (%)	N/A
	X Walk 1 X Slope (%)	6.2		X Walk 2 X Slope (%)	N/A

N/A	Ramp inside XWalk1?	Yes	N/A	Ramp inside XWalk2?	N/A
	Road Slope (%)	N/A	N/A	Clear Space?	N/A
	Road X Slope (%)	N/A	N/A	Clear Space to XWalk (in)	N/A
N/A	Any Obstructions?	N/A	N/A	Storm Grate/Utility Hazard?	N/A
	Obstruction Type			Storm Grate/Utility Type	
		N/A			N/A
			Yes	Surface Condition? (G/P)	Good

Remove & Replace Entire Ramp.
