# Access Compliance Report

## Public Rights-of-Way

### (Curb Ramps)

| Intersection ID: 43689 | Main Street: PORTSTEWART_LN | Cross Street: RISELEY_LN | Location: S |

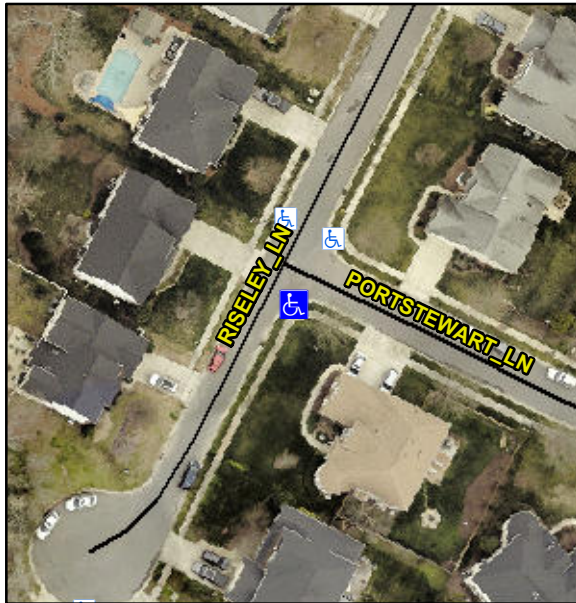
| ADA ID: 752ECFBA04D9 | Ramp Type: PerpDiag | Initial Pass/Fail: Fail | Overall Compliance: No |
| Severity Score: 8.75 | | | |

**Not Found, R304.5.1**

| Compliance | Description | Data | Compliance | Description | Data |
|---|---|---|---|---|---|
| No | Ramp Width (in) | 43.0 | Yes | Ramp XSlope (%) | 1.6 |

**Remove & Replace Curb Ramp With Two New Directional Ramps or Equivalent.**

Total Cost: \$ **3200.00**

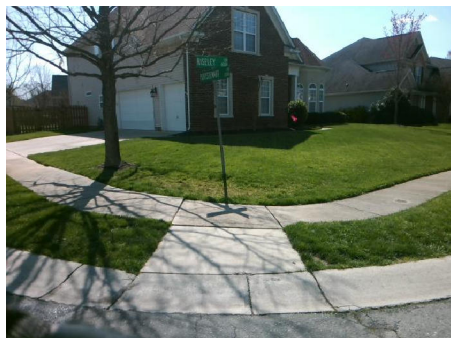
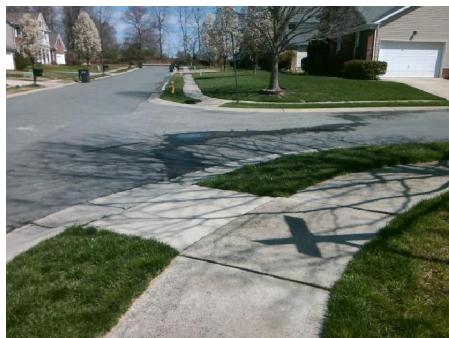
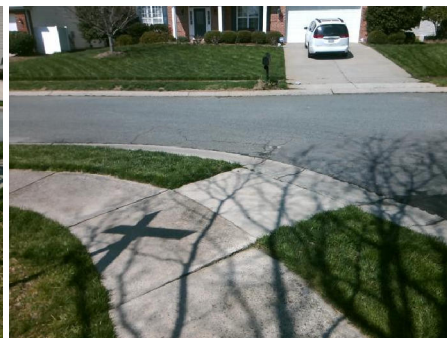
| Compliance | Description | Data | Compliance | Description | Data |
|---|---|---|---|---|---|
| | | | Yes | Surface Condition? (G/P) | Good |
