Access Compliance Report Public Rights-of-Way (Curb Ramps)

Intersection ID: 10036927 Main Street: S_SHARON_AMITY_RD Cross Street: N/A Location: NW

ADA ID: 753BA1CA66C2 Ramp Type: PerpDiag Initial Pass/Fail: Fail Overall Compliance: No Severity Score: 58.75

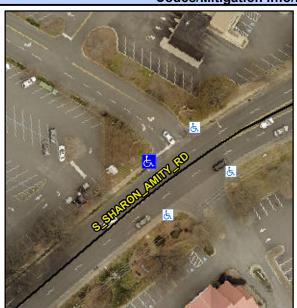
| Compliance Description Data Compliance Description Data | | | | | | |
|---|---|---|---|---|---|---|
| | N/A | Ramp Length (in) | 46.0 | No | Ramp Slope (%) | 13.5 |
| | No | Ramp Width (in) | 44.0 | No | Ramp XSlope (%) | 10.9 |

S SHARON AMITY RD None ENTRANCE StopSign Possible Solutions:

Remove & Replace Curb Ramp With Two New Directional Ramps or Equivalent.

R304.5.1, R304.2.2, R304.5.3
