# Access Compliance Report

## Public Rights-of-Way

### (Curb Ramps)

Intersection ID: 42666	Main Street: WALLACE_GLEN_DR	Cross Street: MUSKOGEE_DR	Location:	N
ADA ID: 75431127A4CD	Ramp Type: Perp	Initial Pass/Fail: Fail	Overall Compliance: No	Severity Score: 25

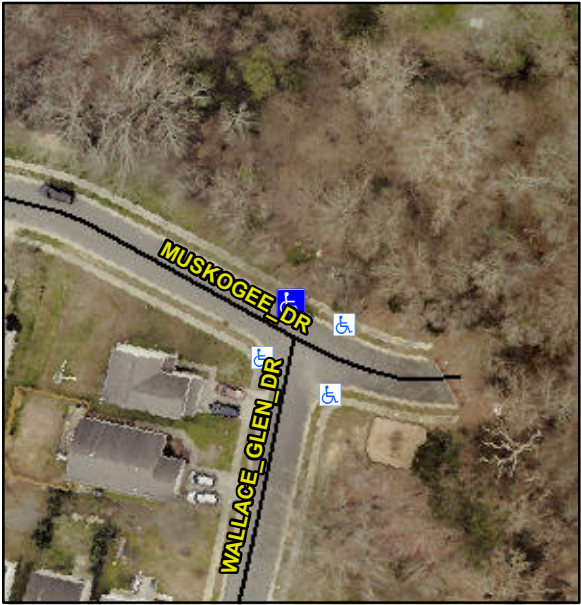
Possible Solutions:		<b>Compliance</b>	<b>Description</b>	<b>Data</b>
	<b>Remove &amp; Replace Entire Ramp.</b>		<b>No</b>	Ramp Slope (%)	<b>15.1</b>
			<b>Yes</b>	Ramp Width (in)	<b>1.1</b>
			<b>N/A</b>	Flare Type LT	<b>N/A</b>
			<b>N/A</b>	Flare Slope LT (%)	<b>N/A</b>
			<b>N/A</b>	Flare Traversable LT?	<b>N/A</b>
			<b>N/A</b>	Landing Length (in)	<b>N/A</b>
			<b>N/A</b>	Landing Width (in)	<b>N/A</b>
			<b>N/A</b>	Landing Slope (%)	<b>N/A</b>
			<b>N/A</b>	Landing X Slope (%)	<b>N/A</b>
<p>Surveyor Notes:</p> <p><b>N/A</b></p> <p>PROW/ADA:</p> <p><b>Not Found, R304.2.2</b></p>			<b>N/A</b>	Flare Type RT	<b>N/A</b>
			<b>N/A</b>	Flare Slope RT (%)	<b>N/A</b>
			<b>N/A</b>	Flare Traversable RT?	<b>N/A</b>
			<b>N/A</b>	DWS Provided?	<b>N/A</b>
			<b>N/A</b>	DWS Contrast?	<b>N/A</b>
			<b>N/A</b>	DWS Length (in)	<b>N/A</b>

<b>N/A</b>	DWS Full Width?	<b>N/A</b>
			<b>N/A</b>	DWS Offset (in)	<b>N/A</b>
			<b>N/A</b>	Shared Landing?	<b>N/A</b>
			<b>N/A</b>	Gutter Ponding?	<b>N/A</b>
<p>Total Cost:</p> <p><b>\$ 1850.00</b></p>			<b>N/A</b>	Gutter X Slope (%)	<b>N/A</b>
			<b>No</b>	Painted X Walk2?	<b>N/A</b>
			<b>To SW</b>	X Walk 2 Direction	<b>N/A</b>
			<b>N/A</b>	X Walk 2 Width (in)	<b>N/A</b>
			<b>2.8</b>	X Walk 2 Slope (%)	<b>N/A</b>
			<b>1.5</b>	X Walk 2 X Slope (%)	<b>N/A</b>
			<b>N/A</b>	Ramp inside XWalk2?	<b>N/A</b>
			<b>N/A</b>	Clear Space?	<b>N/A</b>
			<b>N/A</b>	Clear Space to XWalk (in)	<b>N/A</b>
			<b>N/A</b>	Storm Grate/Utility Hazard?	<b>N/A</b>
<p>Obstruction Type</p> <p><b>N/A</b></p>			<b>N/A</b>	Storm Grate/Utility Type	<b>N/A</b>
			<b>Yes</b>	Surface Condition? (G/P)	<b>Good</b>
