Access Compliance Report Public Rights-of-Way (Curb Ramps)

Intersection ID: N/A Main Street: PROVIDENCE_COUNTRY_CLUBS_ross Street: MCGILL_HEIGHTS_RD Location: NE

ADA ID: 754605341DB3 Ramp Type: Perp Initial Pass/Fail: Fail Overall Compliance: No Severity Score: 12.5

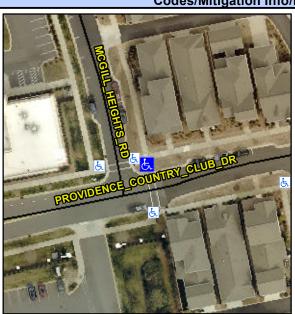
Possible Solution			Field Measurements/Component Compliance						
Possible Solutions:			Compliance Description		Data	Compliance Description			Data
Remove & Replace Entire Ramp.		p.	N/A	Ramp Length (in)	93.0	No	Ramp	Slope (%)	9.0

•		-	Yes	Ramp Width (in)	71.0	Yes	Ramp	XSlope (%)	0.5
			N/A	Flare Type LT	N/A	N/A	Flare	Type RT	N/A
			N/A	Flare Slope LT (%)	N/A	N/A	Flare	Slope RT (%)	N/A
			N/A	Flare Traversable LT?	N/A	N/A	Flare	Traversable RT?	N/A
			N/A	Landing Length (in)	N/A	N/A	DWS	Provided?	N/A
Surveyor Notes:			N/A	Landing Width (in)	N/A	N/A	DWS	Contrast?	N/A
N/A			N/A	Landing Slope (%)	N/A	N/A	DWS	Length (in)	N/A
			N/A	Landing X Slope (%)	N/A	N/A	DWS	Full Width?	N/A
			N/A	Landing Curb? (Y/N)	N/A	N/A	DWS	Offset (in)	N/A
			N/A	Shared Landing?	N/A				
PROW/ADA:			N/A	Gutter Ponding?	N/A	N/A	Gutte	r Slope (%)	N/A
Not Found, R304.2.2			N/A	Gutter Lip Ht (in)	N/A	N/A	Gutte	r X Slope (%)	N/A
,			N/A	Painted X Walk1?	No	N/A	Paint	ed X Walk2?	N/A
				X Walk 1 Direction	To S		X Wa	lk 2 Direction	N/A
			N/A	X Walk 1 Width (in)	N/A	N/A	X Wa	lk 2 Width (in)	N/A
				X Walk 1 Slope (%)	2.3		X Wa	lk 2 Slope (%)	N/A
				X Walk 1 X Slope (%)	0.3		X Wa	lk 2 X Slope (%)	N/A

N/A	Ramp inside XWalk1?	N/A	N/A	Ramp	inside XWalk2?	N/A
			Road Slope (%)	N/A	N/A	Clear	Space?	N/A	
				Road X Slope (%)	N/A	N/A	Clear	Space to XWalk (in)	N/A
			N/A	Any Obstructions?	N/A	N/A	Storm	Grate/Utility Hazard?	N/A
Total Cost:	\$	1850.00		Obstruction Type			Storm	Grate/Utility Type	
					N/A				N/A
						Yes	Surfa	ce Condition? (G/P)	Good
