Access Compliance Report

Public Rights-of-Way

(Curb Ramps)

Intersection ID: 48567	Main Street: CROSSVINE_LN	Cross Street: BRAMBLE_RIDGE_CT	Location: SE
ADA ID: 754A1A900A83	Ramp Type: Perp	Initial Pass/Fail: Pass	Overall Compliance: No
Severity Score: 0			
Codes/Mitigation Info/Possible Solution		Field Measurements/Component Compliance

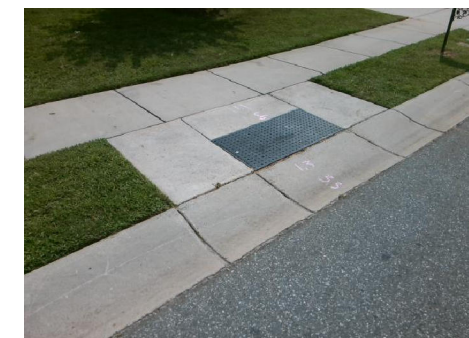
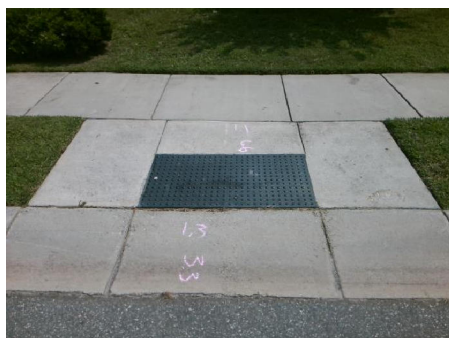
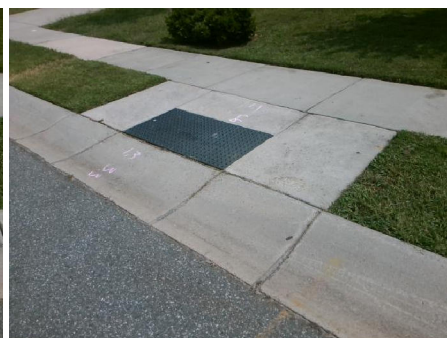
Not Found, R304.5.3, R302.7

Compliance	Description	Data	Compliance	Description	Data
N/A	Ramp Length (in)	47.0	Yes	Ramp Slope (%)	6.6
Yes	Ramp Width (in)	48.0	Yes	Ramp XSlope (%)	1.1
N/A	Flare Type LT	Sloped	N/A	Flare Type RT	N/A
N/A	Flare Slope LT (%)	2.2	N/A	Flare Slope RT (%)	0.8
N/A	Flare Traversable LT?	No	N/A	Flare Traversable RT?	No
Yes	Landing Length (in)	48.0	Yes	DWS Provided?	Yes
Yes	Landing Width (in)	48.0	Yes	DWS Contrast?	Yes
Yes	Landing Slope (%)	0.5	Yes	DWS Length (in)	25.0
No	Landing X Slope (%)	2.4	Yes	DWS Full Width?	Yes
N/A	Landing Curb? (Y/N)	No	Yes	DWS Offset (in)	0.0
N/A	Shared Landing?	No			
No	Gutter Ponding?	Yes	Yes	Gutter Slope (%)	3.4
Yes	Gutter Lip Ht (in)	0.0	Yes	Gutter X Slope (%)	0.9
N/A	Painted X Walk1?	No	N/A	Painted X Walk2?	N/A
	X Walk 1 Direction	To W		X Walk 2 Direction	N/A
N/A	X Walk 1 Width (in)	N/A	N/A	X Walk 2 Width (in)	N/A
	X Walk 1 Slope (%)	3.3		X Walk 2 Slope (%)	N/A
	X Walk 1 X Slope (%)	1.3		X Walk 2 X Slope (%)	N/A

N/A	Ramp inside XWalk1?	N/A	N/A	Ramp inside XWalk2?	N/A
	Road Slope (%)	N/A	N/A	Clear Space?	Yes
	Road X Slope (%)	N/A	N/A	Clear Space to XWalk (in)	N/A
Yes	Any Obstructions?	No	Yes	Storm Grate/Utility Hazard?	No
	Obstruction Type			Storm Grate/Utility Type	
		N/A			N/A
			Yes	Surface Condition? (G/P)	Good

Remove & Replace Entire Ramp.
