# Access Compliance Report

## Public Rights-of-Way

### (Curb Ramps)

| Intersection ID: 16672 | Main Street: EAGLECREST_RD | Cross Street: REDDMAN_RD | Location: S |

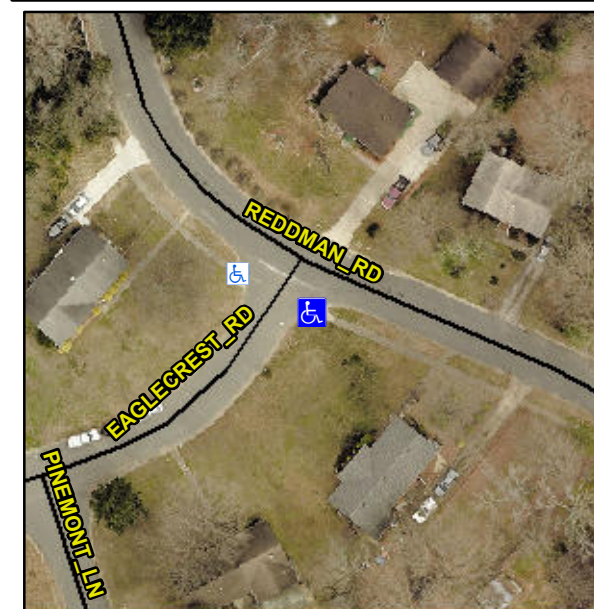
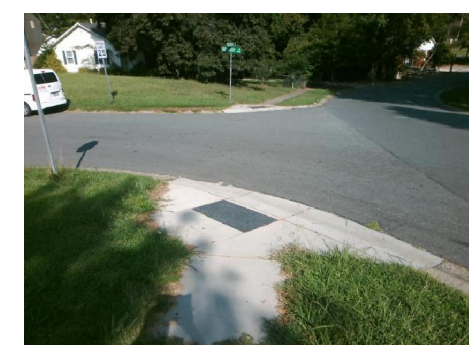
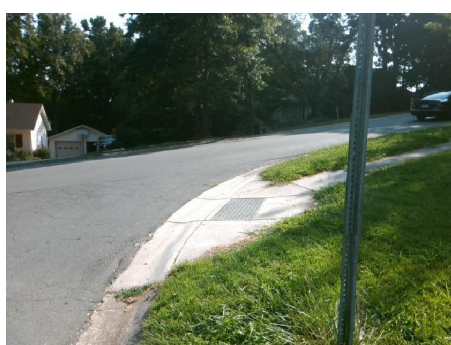
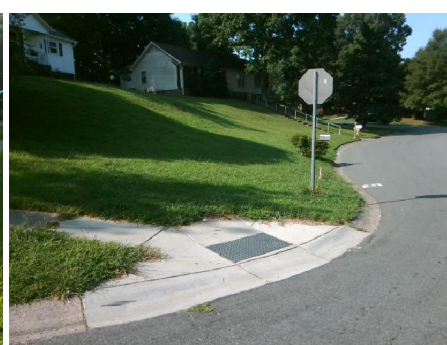
**Not Found, R304.5.1, R304.2.2, R304.5.3**

| Compliance | Description | Data | Compliance | Description | Data |
|---|---|---|---|---|---|
| N/A | Ramp Length (in) | 67.0 | No | Ramp Slope (%) | 14.9 |
| No | Ramp Width (in) | 47.0 | No | Ramp XSlope (%) | 9.0 |

**Remove & Replace Curb Ramp With Two New Directional Ramps or Equivalent.**
