Access Compliance Report Public Rights-of-Way (Curb Ramps)

Main Street: FONTANA_AV Intersection ID: 10000 **Cross Street: WHISNANT ST** Location: NE Initial Pass/Fail: Fail **Overall Compliance: No Severity Score:** 22.5 **ADA ID: 7550CC0DDFEA** Ramp Type: Combination2

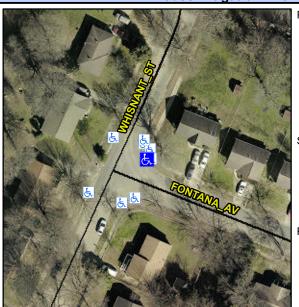
Street 1 Name StopSign **FONTANA AV** Stop Condition-Street 1 Street 2 Name N/A Stop Condition-Street 2 N/A Possible Solutions: Compliance Description N/A Remove & Replace Entire Ramp. Yes No No N/A No Surveyor Notes: N/A RT RP < 5% N/A N/A N/A N/A PROW/ADA: N/A Not Found, R304.5.1, R304.5.3, N/A R304.3.2 N/A N/A N/A
