Access Compliance Report

Public Rights-of-Way

(Curb Ramps)

Intersection ID: N/A	Main Street: FREEDOM_DR	Cross Street: N_I-85_RA	Location: S
ADA ID: 75583E07C810	Ramp Type: Directional1	Initial Pass/Fail: Pass	Overall Compliance: No
Severity Score: 0.25			
Codes/Mitigation Info/Possible Solution		Field Measurements/Component Compliance

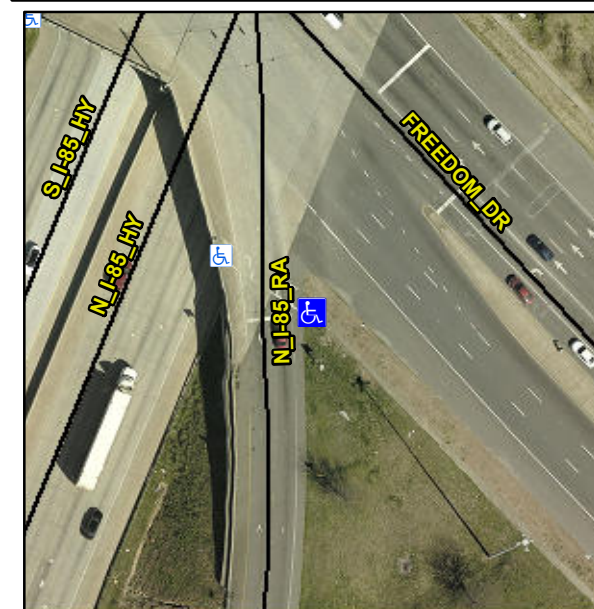
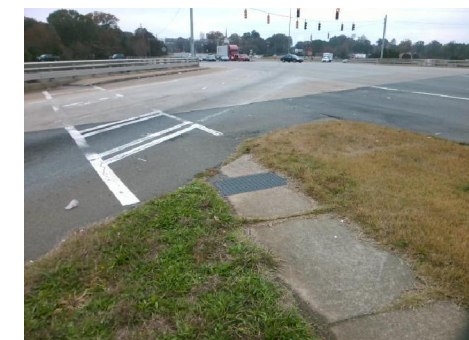
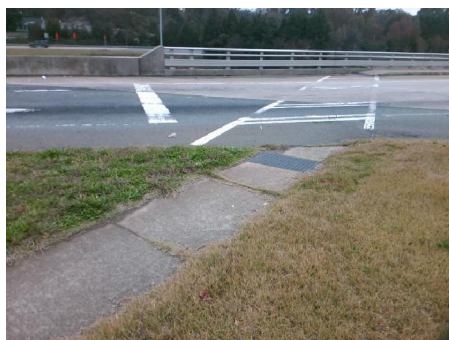
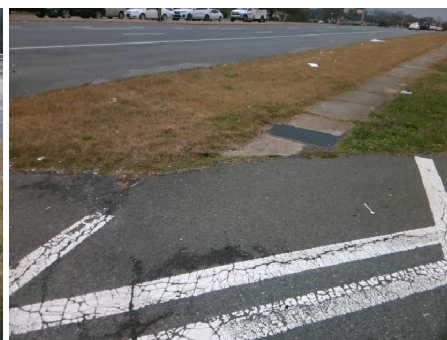
LOCATED ON ISLAND

R304.5.3, R305.2

Compliance	Description	Data	Compliance	Description	Data
N/A	Ramp Length (in)	58.0	Yes	Grade Break?	Yes
Yes	Ramp Width (in)	60.0	Yes	Grade Break Slope (%)	0.3
Yes	Ramp Slope (%)	0.1	No	Grade Break XSlope (%)	3.6
No	Ramp XSlope (%)	2.6			
N/A	Flare Type LT	N/A	N/A	Flare Type RT	N/A
N/A	Flare Slope LT (%)	N/A	N/A	Flare Slope RT (%)	N/A
N/A	Flare Traversable LT?	N/A	N/A	Flare Traversable RT?	N/A
Yes	Landing Length (in)	60.0	Yes	DWS Provided?	Yes
Yes	Landing Width (in)	60.0	Yes	DWS Contrast?	Yes
Yes	Landing Slope (%)	0.9	Yes	DWS Length (in)	24.0
Yes	Landing X Slope (%)	2.0	Yes	DWS Full Width?	Yes
N/A	Landing Curb? (Y/N)	N/A	Yes	DWS Offset LT (in)	53.0
N/A	Shared Landing?	No	No	DWS Offset RT (in)	7.0
Yes	Gutter Ponding?	No	Yes	Gutter Slope (%)	0.6
Yes	Gutter Lip Ht (in)	0.0	Yes	Gutter X Slope (%)	1.4
N/A	Painted X Walk1?	Yes		Road Slope (%)	0.6
	X Walk 1 Direction	To NW		Road X Slope (%)	1.3
	X Walk 1 Width (in)	100.0		Clear Space?	Yes

X Walk 1 Slope (%)	0.6	N/A	Clear Space to XWalk (in)	N/A
	X Walk 1 X Slope (%)	1.3	Yes	Storm Grate/Utility Hazard?	No
Yes	Ramp inside XWalk1?	Yes		Storm Grate/Utility Type	
Yes	Any Obstructions?	No			N/A
	Obstruction Type		Yes	Surface Condition? (G/P)	Good
			N/A	Curb Slope (%)	0.5

Remove & Replace Entire Ramp.
