# Access Compliance Report

## Public Rights-of-Way

### (Curb Ramps)

Intersection ID: 16783	Main Street: HAMPTON_AV	Cross Street: MALVERN_RD	Location: SW
ADA ID: 7561C87498FF	Ramp Type: PerpDiag	Initial Pass/Fail: Fail	Overall Compliance: No
Severity Score: 33.75			
Codes/Mitigation Info/Possible Solution		Field Measurements/Component Compliance

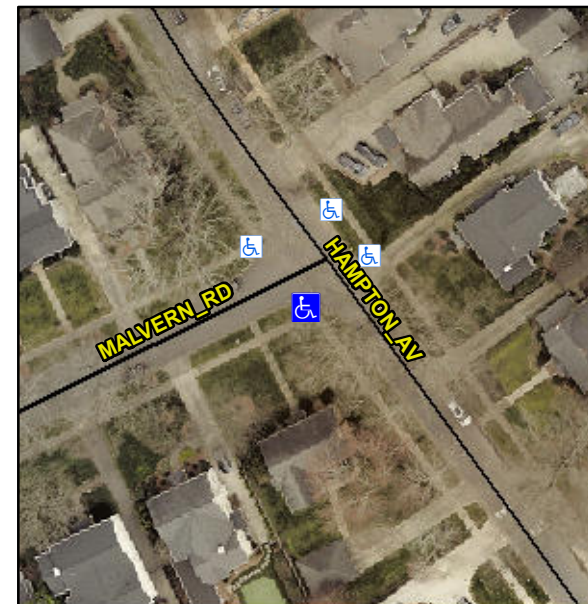
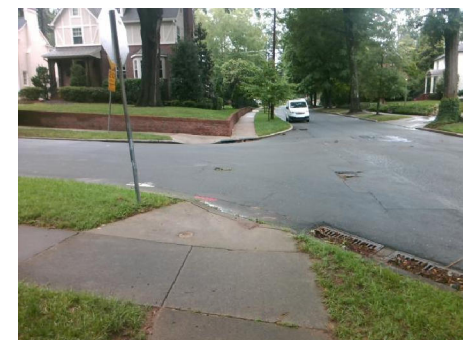
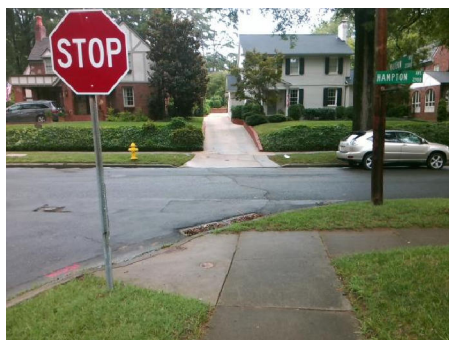
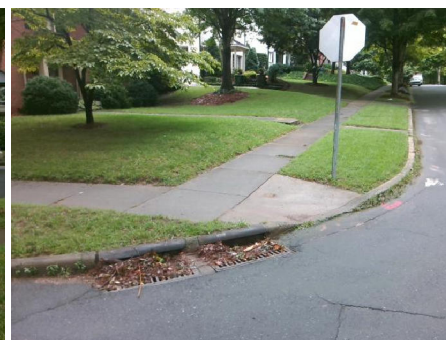
Compliance	Description	Data	Compliance	Description	Data
N/A	Ramp Length (in)	96.0	Yes	Ramp Slope (%)	7.0
No	Ramp Width (in)	39.0	No	Ramp XSlope (%)	9.7
N/A	Flare Type LT	N/A	N/A	Flare Type RT	N/A
N/A	Flare Slope LT (%)	N/A	N/A	Flare Slope RT (%)	N/A
N/A	Flare Traversable LT?	N/A	N/A	Flare Traversable RT?	N/A
N/A	Landing Length (in)	N/A	N/A	DWS Provided?	N/A
N/A	Landing Width (in)	N/A	N/A	DWS Contrast?	N/A
N/A	Landing Slope (%)	N/A	N/A	DWS Length (in)	N/A
N/A	Landing X Slope (%)	N/A	N/A	DWS Full Width?	N/A
N/A	Landing Curb? (Y/N)	N/A	N/A	DWS Offset (in)	N/A
N/A	Shared Landing?	N/A			
N/A	Gutter Ponding?	N/A	N/A	Gutter Slope (%)	N/A
N/A	Gutter Lip Ht (in)	N/A	N/A	Gutter X Slope (%)	N/A
N/A	Painted X Walk1?	No	N/A	Painted X Walk2?	No
	X Walk 1 Direction	To NE		X Walk 2 Direction	To NW
N/A	X Walk 1 Width (in)	N/A	N/A	X Walk 2 Width (in)	N/A
	X Walk 1 Slope (%)	0.2		X Walk 2 Slope (%)	6.3
	X Walk 1 X Slope (%)	6.4		X Walk 2 X Slope (%)	0.4

N/A	Ramp inside XWalk1?	N/A	N/A	Ramp inside XWalk2?	N/A
	Road Slope (%)	2.5	N/A	Clear Space?	N/A
	Road X Slope (%)	8.2	N/A	Clear Space to XWalk (in)	N/A
N/A	Any Obstructions?	N/A	N/A	Storm Grate/Utility Hazard?	N/A
	Obstruction Type			Storm Grate/Utility Type	
		N/A			N/A
			Yes	Surface Condition? (G/P)	Good

**Remove & Replace Curb Ramp With Two New Directional Ramps or Equivalent.**

Total Cost: \$ **3200.00**
