# Access Compliance Report

## Public Rights-of-Way

### (Curb Ramps)

Intersection ID: N/A	Main Street: AGNEW_DR	Cross Street: VAWTER_RD	Location: SE
ADA ID: 7564E566CDE6	Ramp Type: Perp	Initial Pass/Fail: Fail	Overall Compliance: No
Codes/Mitigation Info/Possible Solution		Field Measurements/Component Compliance	
Severity Score: 13.75

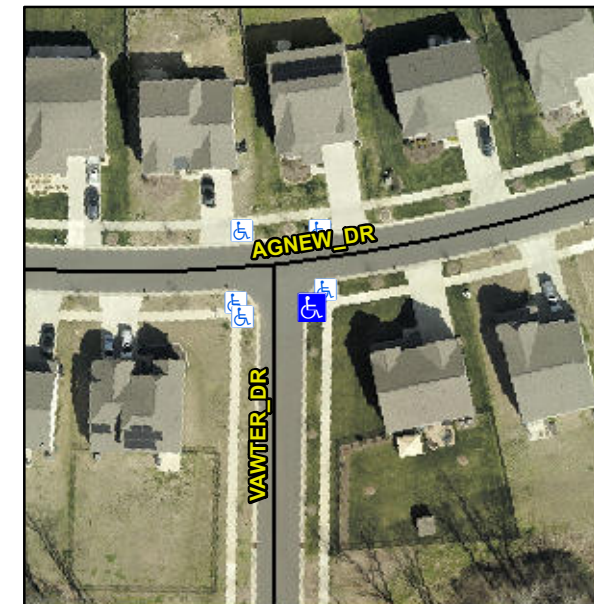
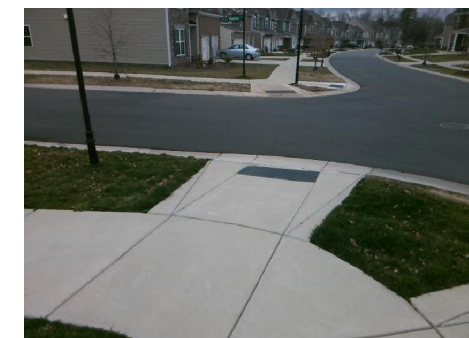
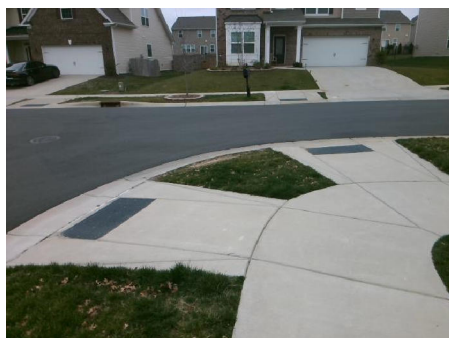
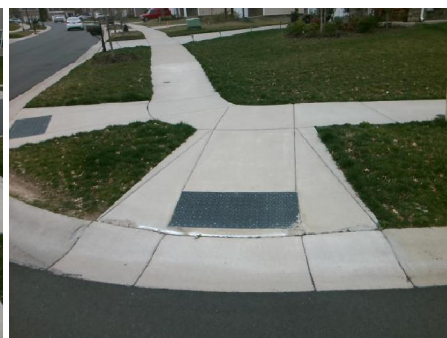
**Not Found, R304.2.2, R304.5.3**

Compliance	Description	Data	Compliance	Description	Data
N/A	Ramp Length (in)	96.0	No	Ramp Slope (%)	9.7
Yes	Ramp Width (in)	48.0	No	Ramp XSlope (%)	3.6
N/A	Flare Type LT	N/A	N/A	Flare Type RT	N/A
N/A	Flare Slope LT (%)	N/A	N/A	Flare Slope RT (%)	N/A
N/A	Flare Traversable LT?	N/A	N/A	Flare Traversable RT?	N/A
N/A	Landing Length (in)	N/A	N/A	DWS Provided?	N/A
N/A	Landing Width (in)	N/A	N/A	DWS Contrast?	N/A
N/A	Landing Slope (%)	N/A	N/A	DWS Length (in)	N/A
N/A	Landing X Slope (%)	N/A	N/A	DWS Full Width?	N/A
N/A	Landing Curb? (Y/N)	N/A	N/A	DWS Offset (in)	N/A
N/A	Shared Landing?	N/A			
N/A	Gutter Ponding?	N/A	N/A	Gutter Slope (%)	N/A
N/A	Gutter Lip Ht (in)	N/A	N/A	Gutter X Slope (%)	N/A
N/A	Painted X Walk1?	No	N/A	Painted X Walk2?	N/A
	X Walk 1 Direction	To W		X Walk 2 Direction	N/A
N/A	X Walk 1 Width (in)	N/A	N/A	X Walk 2 Width (in)	N/A
	X Walk 1 Slope (%)	1.4		X Walk 2 Slope (%)	N/A
	X Walk 1 X Slope (%)	2.8		X Walk 2 X Slope (%)	N/A

N/A	Ramp inside XWalk1?	N/A	N/A	Ramp inside XWalk2?	N/A
	Road Slope (%)	N/A	N/A	Clear Space?	N/A
	Road X Slope (%)	N/A	N/A	Clear Space to XWalk (in)	N/A
N/A	Any Obstructions?	N/A	N/A	Storm Grate/Utility Hazard?	N/A
	Obstruction Type			Storm Grate/Utility Type	
		N/A			N/A
			Yes	Surface Condition? (G/P)	Good

Possible Solutions:

**Remove & Replace Entire Ramp.**

Total Cost: \$ 1850.00
