Access Compliance Report

Public Rights-of-Way

(Curb Ramps)

Intersection ID: 10740	Main Street: PRYOR_ST	Cross Street: TUCKASEEGEE_RD	Location: W
ADA ID: 756AF57D49AD	Ramp Type: Perp	Initial Pass/Fail: Fail	Overall Compliance: No
Severity Score: 12.5			
Codes/Mitigation Info/Possible Solution		Field Measurements/Component Compliance

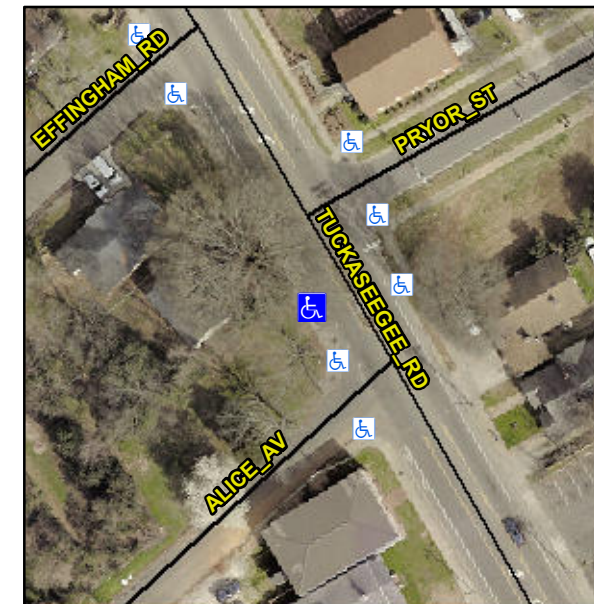
Not Found, R304.2.2

Compliance	Description	Data	Compliance	Description	Data
N/A	Ramp Length (in)	67.0	No	Ramp Slope (%)	11.4
Yes	Ramp Width (in)	48.0	Yes	Ramp XSlope (%)	0.8
N/A	Flare Type LT	N/A	N/A	Flare Type RT	N/A
N/A	Flare Slope LT (%)	N/A	N/A	Flare Slope RT (%)	N/A
N/A	Flare Traversable LT?	N/A	N/A	Flare Traversable RT?	N/A
N/A	Landing Length (in)	N/A	N/A	DWS Provided?	N/A
N/A	Landing Width (in)	N/A	N/A	DWS Contrast?	N/A
N/A	Landing Slope (%)	N/A	N/A	DWS Length (in)	N/A
N/A	Landing X Slope (%)	N/A	N/A	DWS Full Width?	N/A
N/A	Landing Curb? (Y/N)	N/A	N/A	DWS Offset (in)	N/A
N/A	Shared Landing?	N/A			
N/A	Gutter Ponding?	Yes	N/A	Gutter Slope (%)	N/A
N/A	Gutter Lip Ht (in)	N/A	N/A	Gutter X Slope (%)	N/A
N/A	Painted X Walk1?	No	N/A	Painted X Walk2?	N/A
	X Walk 1 Direction	To E		X Walk 2 Direction	N/A
N/A	X Walk 1 Width (in)	N/A	N/A	X Walk 2 Width (in)	N/A
	X Walk 1 Slope (%)	7.2		X Walk 2 Slope (%)	N/A
	X Walk 1 X Slope (%)	0.8		X Walk 2 X Slope (%)	N/A

N/A	Ramp inside XWalk1?	N/A	N/A	Ramp inside XWalk2?	N/A
	Road Slope (%)	N/A	N/A	Clear Space?	N/A
	Road X Slope (%)	N/A	N/A	Clear Space to XWalk (in)	N/A
N/A	Any Obstructions?	N/A	N/A	Storm Grate/Utility Hazard?	N/A
	Obstruction Type			Storm Grate/Utility Type	
		N/A			N/A
			Yes	Surface Condition? (G/P)	Good

Remove & Replace Entire Ramp.

Total Cost: \$ 1850.00
