Access Compliance Report

Public Rights-of-Way

(Curb Ramps)

| Intersection ID: 11389 | Main Street: E_18TH_ST | Cross Street: N_CALDWELL_ST | Location: W |

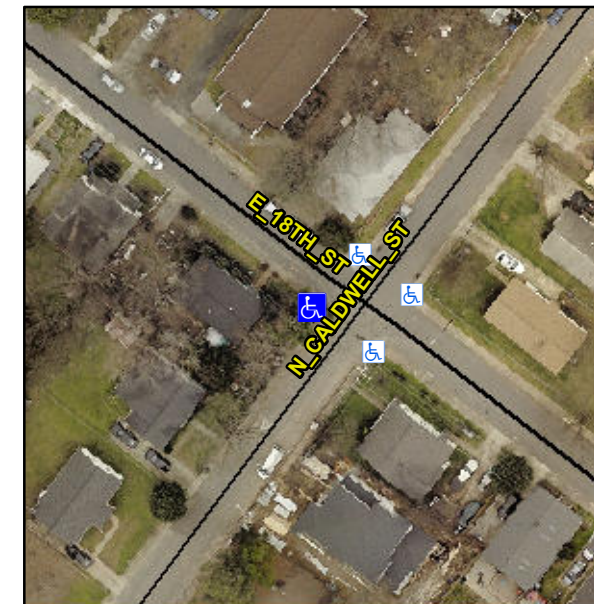
Not Found, R304.5.1, R304.2.2

| Compliance | Description | Data | Compliance | Description | Data |
|---|---|---|---|---|---|
| N/A | Ramp Length (in) | 42.5 | No | Ramp Slope (%) | 11.4 |
| No | Ramp Width (in) | 43.0 | Yes | Ramp XSlope (%) | 0.6 |

Remove & Replace Curb Ramp With Two New Directional Ramps or Equivalent.
