## **Access Compliance Report Public Rights-of-Way** (Curb Ramps)

Intersection ID: 10027081 Main Street: GALLERIA BV **Cross Street: N/A** Location: NW Initial Pass/Fail: Fail ADA ID: 759B90236B00 Ramp Type: PerpDiag **Overall Compliance: No Severity Score:** 8.75

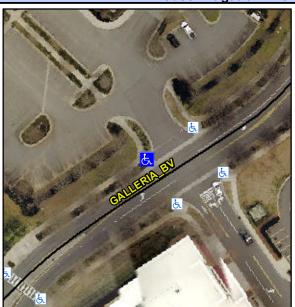
**GALLERIA BV** Street 1 Name Stop Condition-Street 2 None Street 2 Name **ENTRANCE** Stop Condition-Street 1 None Possible Solutions: Remove & Replace Curb Ramp With **Two New Directional Ramps or** Equivalent. Surveyor Notes: N/A PROW/ADA: R304.5.1

Field Measurements/Component Compliance							
	Compliance Description		Data	Compliance Description		Data	
	N/A	Ramp Length (in)	96.0	Yes	Ramp	Slope (%)	7.9
	No	Ramp Width (in)	38.3	Yes	Ramp	XSlope (%)	0.4
	N/A	Flare Type LT	N/A	N/A	Flare	Type RT	N/A
	N/A	Flare Slope LT (%)	N/A	N/A	Flare	Slope RT (%)	N/A
	N/A	Flare Traversable LT?	N/A	N/A	Flare	Traversable RT?	N/A
	N/A	Landing Length (in)	N/A	N/A	DWS	Provided?	N/A
	N/A	Landing Width (in)	N/A	N/A	DWS	Contrast?	N/A
	N/A	Landing Slope (%)	N/A	N/A	DWS	Length (in)	N/A
	N/A	Landing X Slope (%)	N/A	N/A	DWS	Full Width?	N/A
	N/A	Landing Curb? (Y/N)	N/A	N/A	DWS	Offset (in)	N/A
	N/A	Shared Landing?	N/A				
	N/A	Gutter Ponding?	N/A	N/A	Gutte	er Slope (%)	N/A
	N/A	Gutter Lip Ht (in)	N/A	N/A	Gutte	r X Slope (%)	N/A
	N/A	Painted X Walk1?	No	N/A	Paint	ed X Walk2?	No
		X Walk 1 Direction	To SE		X Wa	lk 2 Direction	To NE
	N/A	X Walk 1 Width (in)	N/A	N/A	X Wa	lk 2 Width (in)	N/A

X Walk 1 Slope (%)	1.3		X Wa	lk 2 Slope (%)	0.0
		X Walk 1 X Slope (%)	0.7		X Wa	lk 2 X Slope (%)	0.0
	N/A	Ramp inside XWalk1?	N/A	N/A	Ram	o inside XWalk2?	N/A
		Road Slope (%)	1.2	N/A	Clear	Space?	N/A
		Road X Slope (%)	0.7	N/A	Clear	Space to XWalk (in)	N/A
	N/A	Any Obstructions?	N/A	N/A	Storn	n Grate/Utility Hazard?	N/A
		Obstruction Type			Storn	n Grate/Utility Type	
			N/A				N/A
				Yes	Surfa	ce Condition? (G/P)	Good
