Access Compliance Report

Public Rights-of-Way

(Curb Ramps)

Intersection ID: 3953		Main Street: BENTHAVEN_LN		Cross Street: COLESHIRE_CT		Location:		SW									
ADA ID: 75A672203F22		Ramp Type: Directional1		Initial Pass/Fail: Fail		Overall Compliance: No		Severity Score: 22.5									
Codes/Mitigation Info/Possible Solution				Field Measurements/Component Compliance

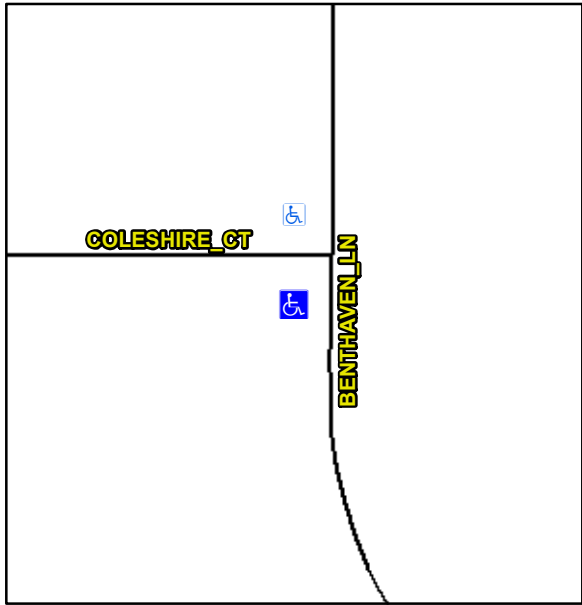
Possible Solutions:		Compliance		Description		Data		Compliance		Description		Data	
				Remove & Replace Entire Ramp.		N/A		Ramp Length (in)		62.0		N/A		Grade Break?		N/A	
				Surveyor Notes:		No		Ramp Width (in)		47.0		N/A		Grade Break Slope (%)		0.0	
				N/A		No		Ramp Slope (%)		9.8		N/A		Grade Break XSlope (%)		0.0	
				PROW/ADA:		No		Ramp XSlope (%)		3.5		N/A		Flare Type LT		N/A	
				R304.5.1, R304.2.2, R304.5.3		N/A		Flare Slope LT (%)		N/A		N/A		Flare Slope RT (%)		0.0	
						N/A		Flare Traversable LT?		N/A		N/A		Flare Traversable RT?		N/A	
						N/A		Landing Length (in)		0.0		N/A		DWS Provided?		N/A

N/A		Landing Width (in)		0.0		N/A		DWS Contrast?		N/A	
						N/A		Landing Slope (%)		0.0		N/A		DWS Length (in)		N/A	
						N/A		Landing X Slope (%)		0.0		N/A		DWS Full Width?		N/A	
						N/A		Landing Curb? (Y/N)		N/A		N/A		DWS Offset LT (in)		N/A	
						N/A		Shared Landing?		N/A		N/A		DWS Offset RT (in)		N/A	
						N/A		Gutter Ponding?		0.0		N/A		Gutter Slope (%)		N/A	
						N/A		Gutter Lip Ht (in)		0.0		N/A		Gutter X Slope (%)		N/A	
						N/A		Painted X Walk1?		No				Road Slope (%)		3.5	
								X Walk 1 Direction		To N				Road X Slope (%)		0.2	
								X Walk 1 Width (in)		N/A				Clear Space?		N/A	
								X Walk 1 Slope (%)		3.5		N/A		Clear Space to XWalk (in)		N/A	
								X Walk 1 X Slope (%)		0.2		N/A		Storm Grate/Utility Hazard?		N/A	
						N/A		Ramp inside XWalk1?		N/A				Storm Grate/Utility Type			
						N/A		Any Obstructions?		N/A							
								Obstruction Type				Yes		Surface Condition? (G/P)		Good

N/A		N/A		Curb Slope (%)	
				Total Cost:		\$		1600.00
