Access Compliance Report Public Rights-of-Way (Curb Ramps)

•							
Intersection ID: 49920	section ID: 49920 Main Street: AUSTIN_DEKOTA_DR Cros				WANAMASSA_DR	Location:	Е		
ADA ID: 75ACF77781A4	Ramp Ty	Ramp Type: PerpDiag Initia			al Pass/Fail: Pass Overall Compliance: No			o Severity Score:	0
Codes/Mitigation Info/Possible Solution				Field Measurements/Component Compliance					
15-11-1-1-1-1-1-1-1-1-1-1-1-1-1-1-1-1-1		Possible Solutions:		Compliance Description		Data Compliance Description		Data	
		Remove & Replace Curb Ramp Two New Directional Ramps or Equivalent.	p With	N/A	Ramp Length (in)	48.0	Yes	Ramp Slope (%)	6.9

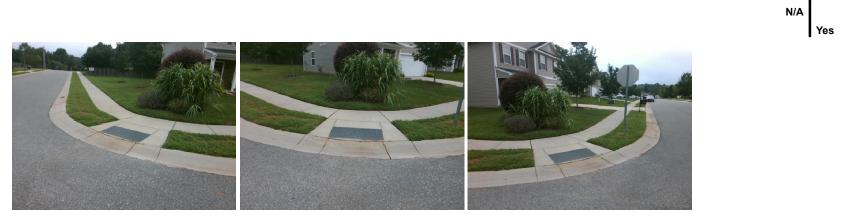
•	Yes	Ramp Width (in)	48.0	Yes	Ramp XSlope (%)	0.1
				N/A	Flare Type LT	Sloped	N/A	Flare Type RT	N/A
				N/A	Flare Slope LT (%)	7.6	N/A	Flare Slope RT (%)	7.2
				N/A	Flare Traversable LT?	No	N/A	Flare Traversable RT?	No
				Yes	Landing Length (in)	48.0	Yes	DWS Provided?	Yes
6		Surveyor Notes:		Yes	Landing Width (in)	48.0	Yes	DWS Contrast?	Yes
A Room		N/A		No	Landing Slope (%)	3.0	Yes	DWS Length (in)	24.5
BAR BAR BAR				Yes	Landing X Slope (%)	0.3	Yes	DWS Full Width?	Yes
A A A A A A A A A A A A A A A A A A A				N/A	Landing Curb? (Y/N)	No	No	DWS Offset (in)	3.5
	A CONTRACTOR	1		N/A	Shared Landing?	No			
	New /	PROW/ADA:		Yes	Gutter Ponding?	No	Yes	Gutter Slope (%)	4.7
and the AS	CALL O	Not Found, R304.2.2-Perp, R	04.3.2-	Yes	Gutter Lip Ht (in)	0.0	Yes	Gutter X Slope (%)	0.2
	A Contra	Para, R305.2	•	N/A	Painted X Walk1?	No	N/A	Painted X Walk2?	No
and the second	130	, i i i i i i i i i i i i i i i i i i i			X Walk 1 Direction	To NW		X Walk 2 Direction	To E

V / Am			N/A	X Walk 1 Width (in)	N/A	N/A	X Walk 2 Width (in)	N/A
Street 1 Name	WANAMASSA DR	-			X Walk 1 Slope (%)	2.8		X Walk 2 Slope (%)	0.9
Stop Condition-Street 2	None				X Walk 1 X Slope (%)	2.1		X Walk 2 X Slope (%)	2.0
Street 2 Name	AUSTIN DEKOTA DR			N/A	Ramp inside XWalk1?	N/A	N/A	Ramp inside XWalk2?	N/A
Stop Condition-Street 1	StopSign				Road Slope (%)	0.3	N/A	Clear Space?	Yes
					Road X Slope (%)	1.4	N/A	Clear Space to XWalk (in)	N/A
				Yes	Any Obstructions?	No	Yes	Storm Grate/Utility Hazard?	No
		Total Cost: \$	3200.00		Obstruction Type			Storm Grate/Utility Type	
						N/A			N/A

s Surface Condition? (G/P)

Good
