Access Compliance Report Public Rights-of-Way (Curb Ramps)

Cross Street: N/A Intersection ID: 9231 Main Street: THE PLAZA Location: SW Initial Pass/Fail: Fail **Overall Compliance: No** ADA ID: 75B0C2C39E38 Ramp Type: Combination2 **Severity Score:** 8.75

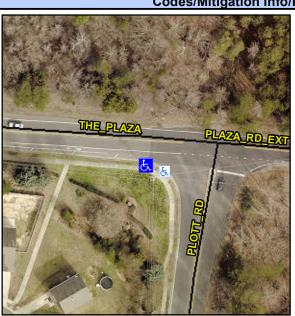
Possible Solutions: Compliance Description N/A Remove & Replace Entire Ramp. N/A N/A N/A N/A No Surveyor Notes: N/A LT RP < 5% N/A N/A N/A N/A PROW/ADA: N/A Not Found, R304.5.1 N/A N/A N/A N/A N/A N/A
