Access Compliance Report

Public Rights-of-Way

(Curb Ramps)

Intersection ID: 11367	Main Street: FINCHLEY_DR	Cross Street: SHAMROCK_DR	Location: NE
ADA ID: 75C61D4C4308	Ramp Type: Combination1	Initial Pass/Fail: Fail	Overall Compliance: No
			Severity Score: 18.75

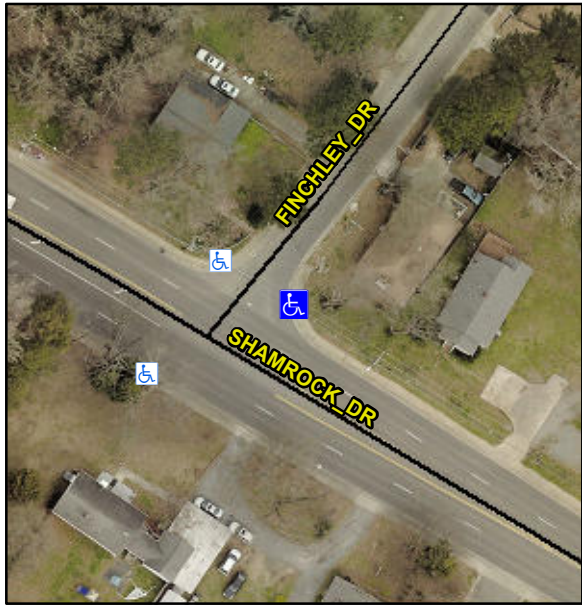
Possible Solutions:			Compliance	Description	Data	Compliance	Description	Data		
	Remove & Replace Entire Ramp.			N/A	Ramp Length LT (in)	35.0	N/A	Ramp Length RT (in)	36.5		
	Remove & Replace Sidewalk.			No	Ramp Width LT (in)	37.0	No	Ramp Width RT (in)	35.0		
				Yes	Ramp Slope LT (%)	6.0	Yes	Ramp Slope RT (%)	1.7		
				No	Ramp XSlope LT (%)	4.4	No	Ramp XSlope RT (%)	2.4		
				N/A	Ramp Length (in)	24.5	Yes	Ramp Slope (%)	7.8		
				Yes	Ramp Width (in)	48.0	Yes	Ramp XSlope (%)	0.3		
	Surveyor Notes:			N/A	Flare Type LT	N/A	N/A	Flare Type RT	N/A		
	RT RP < 5%			N/A	Flare Slope LT (%)	N/A	N/A	Flare Slope RT (%)	N/A		
				N/A	Flare Traversable LT?	N/A	N/A	Flare Traversable RT?	N/A		
PROW/ADA:			N/A	Landing Length (in)	N/A	N/A	DWS Provided?	N/A			
Not Found, R304.5.1, R304.5.3			N/A	Landing Width (in)	N/A	N/A	DWS Contrast?	N/A

N/A	Landing Slope (%)	N/A	N/A	DWS Length (in)	N/A			
			N/A	Landing X Slope (%)	N/A	N/A	DWS Full Width?	N/A			
			N/A	Landing Curb? (Y/N)	N/A	N/A	DWS Offset (in)	N/A			
			N/A	Shared Landing?	N/A						
			N/A	Gutter Ponding?	N/A	N/A	Gutter Slope (%)	N/A			
			N/A	Gutter Lip Ht (in)	N/A	N/A	Gutter X Slope (%)	N/A			
			N/A	Painted X Walk1?	No	N/A	Painted X Walk2?	N/A			
				X Walk 1 Direction	To NW		X Walk 2 Direction	N/A			
				X Walk 1 Width (in)	N/A		X Walk 2 Width (in)	N/A			
				X Walk 1 Slope (%)	2.2		X Walk 2 Slope (%)	N/A			
				X Walk 1 X Slope (%)	0.1		X Walk 2 X Slope (%)	N/A			
			N/A	Ramp inside XWalk1?	N/A	N/A	Ramp inside XWalk2?	N/A			
				Road Slope (%)	N/A		Clear Space?	N/A			
				Road X Slope (%)	N/A	N/A	Clear Space to XWalk (in)	N/A			
						N/A	Any Obstruction?	N/A			
							Obstruction Type	N/A			
						N/A	Storm Grate/Utility Hazard?	N/A			
							Storm Grate/Utility Type	N/A			
			Yes	Surface Condition? (G/P)				Good

Curb Slope (%)				27.1			
Street 1 Name				StopSign							
Stop Condition-Street 1				FINCHLEY DR							
Street 2 Name				N/A							
Stop Condition-Street 2				N/A							
Total Cost:				\$	2200.00
