# Access Compliance Report

## Public Rights-of-Way

### (Curb Ramps)

| Intersection ID: N/A | Main Street: RIDGE_OAK_DR | Cross Street: CAROLINA_CROSSING_DR | Location: SW |

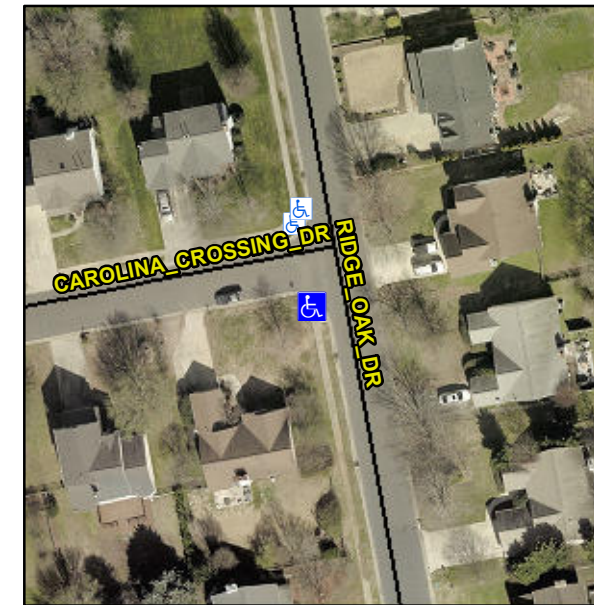
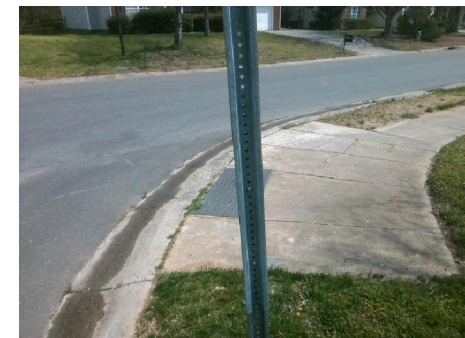
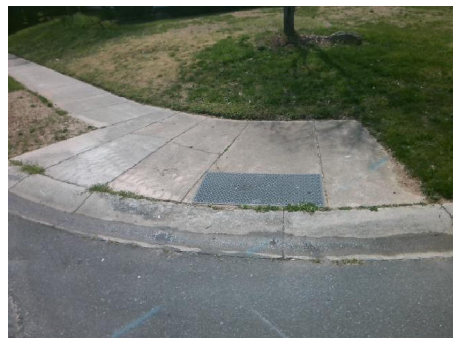
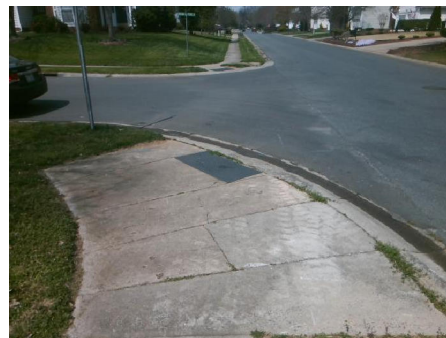
| ADA ID: 75D83D62FCAC | Ramp Type: BlendTrans2 | Initial Pass/Fail: Fail | Overall Compliance: No |

| | | Severity Score: 10 | |

**Not Found, R304.5.1, R304.5.3**

| Compliance | Description | Data | Compliance | Description | Data |
|---|---|---|---|---|---|
| No | Ramp Width (in) | 36.0 | No | BlendTrans XSlope (%) | 4.0 |
| | | | No | Curb Slope (%) | 12.1 |

**Remove & Replace Curb Ramp With Two New Directional Ramps or Equivalent.**
