Access Compliance Report

Public Rights-of-Way

(Curb Ramps)

Intersection ID: N/A	Main Street: MCCLINTOCK_RD	Cross Street: N/A	Location: NW
ADA ID: 75DFA2C8D3E6	Ramp Type: Perp	Initial Pass/Fail: Fail	Overall Compliance: No
Severity Score: 13.75			
Codes/Mitigation Info/Possible Solution		Field Measurements/Component Compliance

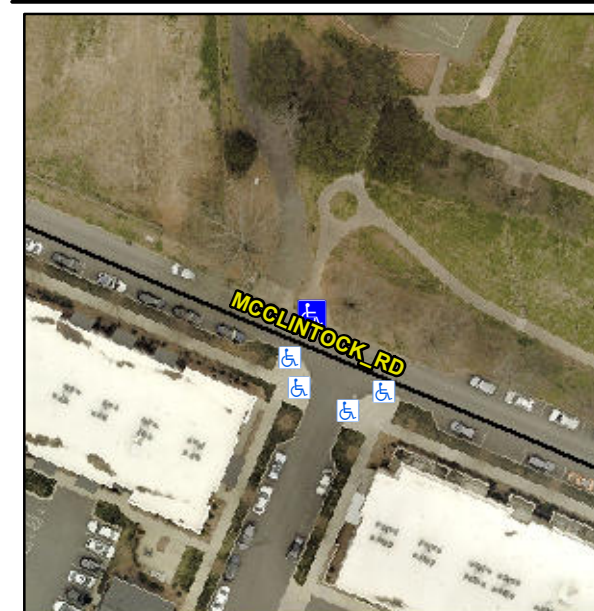
Not Found, R304.2.2, R304.5.3

Compliance	Description	Data	Compliance	Description	Data
N/A	Ramp Length (in)	70.5	No	Ramp Slope (%)	11.7
Yes	Ramp Width (in)	49.5	No	Ramp XSlope (%)	3.7
N/A	Flare Type LT	N/A	N/A	Flare Type RT	N/A
N/A	Flare Slope LT (%)	N/A	N/A	Flare Slope RT (%)	N/A
N/A	Flare Traversable LT?	N/A	N/A	Flare Traversable RT?	N/A
N/A	Landing Length (in)	N/A	N/A	DWS Provided?	N/A
N/A	Landing Width (in)	N/A	N/A	DWS Contrast?	N/A
N/A	Landing Slope (%)	N/A	N/A	DWS Length (in)	N/A
N/A	Landing X Slope (%)	N/A	N/A	DWS Full Width?	N/A
N/A	Landing Curb? (Y/N)	N/A	N/A	DWS Offset (in)	N/A
N/A	Shared Landing?	N/A			
N/A	Gutter Ponding?	N/A	N/A	Gutter Slope (%)	N/A
N/A	Gutter Lip Ht (in)	N/A	N/A	Gutter X Slope (%)	N/A
N/A	Painted X Walk1?	No	N/A	Painted X Walk2?	N/A
	X Walk 1 Direction	To S		X Walk 2 Direction	N/A
N/A	X Walk 1 Width (in)	N/A	N/A	X Walk 2 Width (in)	N/A
	X Walk 1 Slope (%)	5.2		X Walk 2 Slope (%)	N/A
	X Walk 1 X Slope (%)	2.1		X Walk 2 X Slope (%)	N/A

N/A	Ramp inside XWalk1?	N/A	N/A	Ramp inside XWalk2?	N/A
	Road Slope (%)	N/A	N/A	Clear Space?	N/A
	Road X Slope (%)	N/A	N/A	Clear Space to XWalk (in)	N/A
N/A	Any Obstructions?	N/A	N/A	Storm Grate/Utility Hazard?	N/A
	Obstruction Type			Storm Grate/Utility Type	
		N/A			N/A
		Yes		Surface Condition? (G/P)	Good

Remove & Replace Entire Ramp.
