## Access Compliance Report Public Rights-of-Way (Curb Ramps)

Intersection ID: 10589 Main Street: N\_GRAHAM\_ST Cross Street: ARMOUR\_DR Location: E

ADA ID: 75EB80A34D54 Ramp Type: PerpDiag Initial Pass/Fail: Fail Overall Compliance: No Severity Score: 12.5

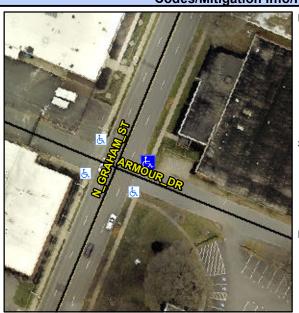
PROW/ADA:
Not Found, R304.2.2

| Compliance Description Data Compliance Description | | | | | | Data |
|--|---|---|---|---|---|---|
| | N/A | Ramp Length (in) | 64.0 | No | Ramp Slope (%) | 8.6 |

Remove & Replace Curb Ramp With
Two New Directional Ramps or
Equivalent.
