Access Compliance Report

Public Rights-of-Way

(Curb Ramps)

Intersection ID: 5250	Main Street: AUSTIN RIDGE LN	Cross Street: CAMERON SPRING RD	Location: E
ADA ID: 75EF7EDBF8B7	Ramp Type: Perp	Initial Pass/Fail: Fail	Overall Compliance: No
Severity Score: 13.75			
Codes/Mitigation Info/Possible Solution		Field Measurements/Component Compliance

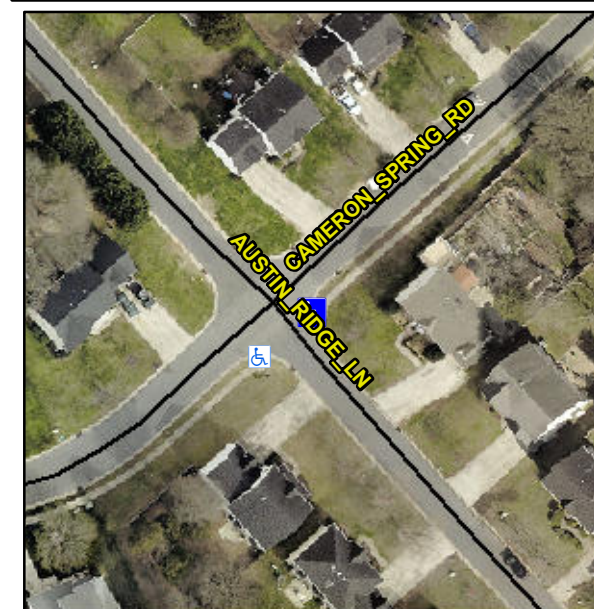
Not Found, R304.2.2, R304.5.3

Compliance	Description	Data	Compliance	Description	Data
N/A	Ramp Length (in)	44.0	No	Ramp Slope (%)	10.8
Yes	Ramp Width (in)	51.0	No	Ramp XSlope (%)	2.7
N/A	Flare Type LT	N/A	N/A	Flare Type RT	N/A
N/A	Flare Slope LT (%)	N/A	N/A	Flare Slope RT (%)	N/A
N/A	Flare Traversable LT?	N/A	N/A	Flare Traversable RT?	N/A
N/A	Landing Length (in)	N/A	N/A	DWS Provided?	N/A
N/A	Landing Width (in)	N/A	N/A	DWS Contrast?	N/A
N/A	Landing Slope (%)	N/A	N/A	DWS Length (in)	N/A
N/A	Landing X Slope (%)	N/A	N/A	DWS Full Width?	N/A
N/A	Landing Curb? (Y/N)	N/A	N/A	DWS Offset (in)	N/A
N/A	Shared Landing?	N/A			
N/A	Gutter Ponding?	N/A	N/A	Gutter Slope (%)	N/A
N/A	Gutter Lip Ht (in)	N/A	N/A	Gutter X Slope (%)	N/A
N/A	Painted X Walk1?	No	N/A	Painted X Walk2?	N/A
	X Walk 1 Direction	To SW		X Walk 2 Direction	N/A
N/A	X Walk 1 Width (in)	N/A	N/A	X Walk 2 Width (in)	N/A
	X Walk 1 Slope (%)	1.8		X Walk 2 Slope (%)	N/A
	X Walk 1 X Slope (%)	1.3		X Walk 2 X Slope (%)	N/A

N/A	Ramp inside XWalk1?	N/A	N/A	Ramp inside XWalk2?	N/A
	Road Slope (%)	N/A	N/A	Clear Space?	N/A
	Road X Slope (%)	N/A	N/A	Clear Space to XWalk (in)	N/A
N/A	Any Obstructions?	N/A	N/A	Storm Grate/Utility Hazard?	N/A
	Obstruction Type			Storm Grate/Utility Type	
		N/A			N/A
			Yes	Surface Condition? (G/P)	Good

Possible Solutions:

Remove & Replace Entire Ramp.

Total Cost: \$ 1850.00
