Access Compliance Report Public Rights-of-Way (Curb Ramps)

Intersection ID: 49252 Main Street: ROCKLAND DR Cross Street: BROOKE_NICOLE_PL Location: Ε ADA ID: 75F7AAA0ADA2 Ramp Type: Perp Initial Pass/Fail: Fail **Overall Compliance: No Severity Score:** 25

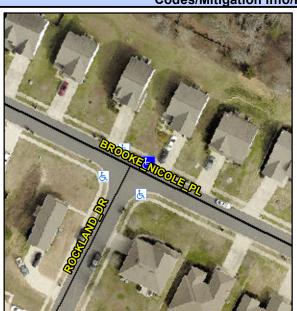
N/A Ramp Length (in) 48.0 Yes Ramp Slope (%) 8 Yes Ramp Width (in) 48.0 No Ramp XSlope (%) 7 N/A Flare Type LT N/A N/A Flare Type RT N N/A Flare Slope LT (%) N/A Flare Slope RT (%) N	ata 3.0 7.2 I/A
Yes Ramp Width (in) 48.0 No Ramp XSlope (%) N/A Flare Type LT N/A N/A Flare Type RT N/A N/A Flare Slope LT (%) N/A N/A Flare Slope RT (%) N/A	7.2
N/A Flare Type LT N/A N/A Flare Type RT N/A N/A Flare Slope RT (%)	
N/A Flare Slope LT (%) N/A N/A Flare Slope RT (%)	1/A
N/A Flare Traversable LT? N/A N/A Flare Traversable RT? N	I/A
	I/A
N/A Landing Length (in) N/A N/A DWS Provided?	I/A
N/A Landing Width (in) N/A N/A DWS Contrast?	I/A
N/A Landing Slope (%) N/A N/A DWS Length (in)	I/A
N/A Landing X Slope (%) N/A N/A DWS Full Width?	I/A
N/A Landing Curb? (Y/N) N/A N/A DWS Offset (in)	I/A
N/A Shared Landing? N/A	
N/A Gutter Ponding? N/A N/A Gutter Slope (%)	I/A
N/A Gutter Lip Ht (in) N/A N/A Gutter X Slope (%)	I/A

N/A Painted X Walk1? No N/A Painted X Walk2? N	I/A
X Walk 1 Direction To S X Walk 2 Direction	I/A
N/A X Walk 1 Width (in) N/A N/A X Walk 2 Width (in)	I/A
X Walk 1 Slope (%) 3.8 X Walk 2 Slope (%)	I/A
X Walk 1 X Slope (%) 8.7 X Walk 2 X Slope (%)	I/A
N/A Ramp inside XWalk1? N/A Ramp inside XWalk2? N	I/A
Road Slope (%) N/A N/A Clear Space?	I/A
Road X Slope (%) N/A N/A Clear Space to XWalk (in)	I/A
N/A Any Obstructions? N/A N/A Storm Grate/Utility Hazard? N	I/A
Obstruction Type Storm Grate/Utility Type	
N/A	I/A
Yes Surface Condition? (G/P) Go	od

BROOKE NICOLE PL Street 1 Name Stop Condition-Street 2 None Street 2 Name N/A Stop Condition-Street 1 N/A Possible Solutions: Remove & Replace Entire Ramp. Surveyor Notes: N/A PROW/ADA: Not Found, R304.5.3
