# Access Compliance Report

## Public Rights-of-Way

### (Curb Ramps)

Intersection ID: 50604	Main Street: RHODORA_RD	Cross Street: LAMINA_CT	Location: SW
ADA ID: 75F90869F703	Ramp Type: Perp	Initial Pass/Fail: Fail	Overall Compliance: No
Severity Score: 10			
Codes/Mitigation Info/Possible Solution		Field Measurements/Component Compliance

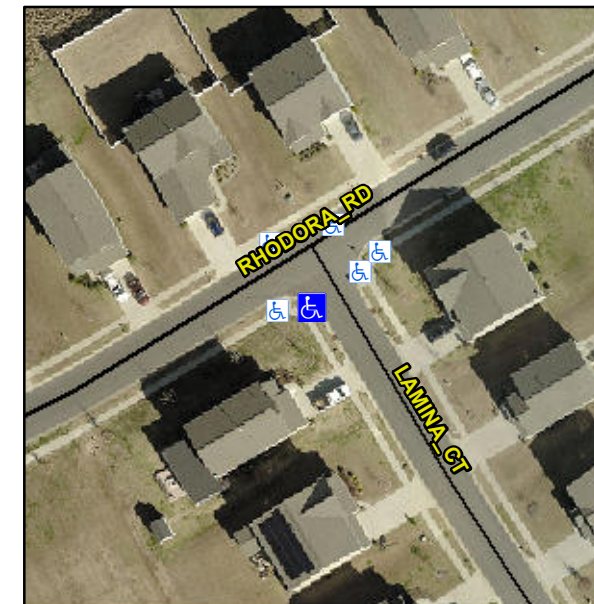
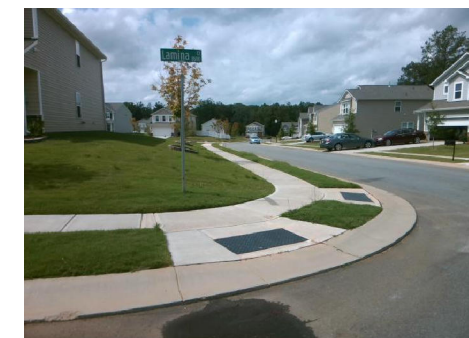
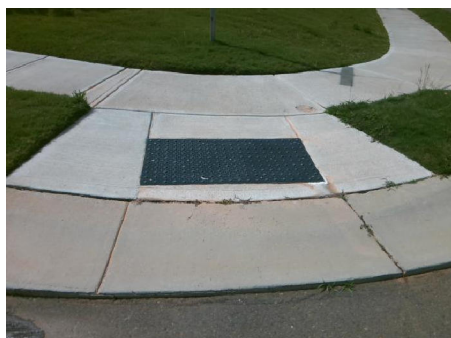
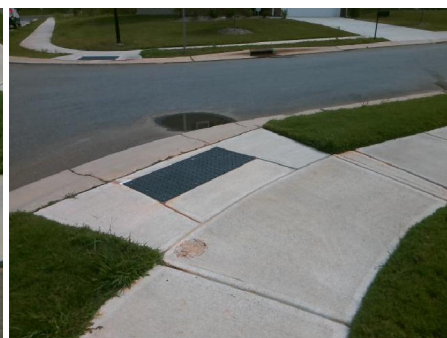
**Not Found, R304.5.1, R304.5.3**

Compliance	Description	Data	Compliance	Description	Data
N/A	Ramp Length (in)	48.5	Yes	Ramp Slope (%)	5.7
No	Ramp Width (in)	46.0	No	Ramp XSlope (%)	3.5
N/A	Flare Type LT	N/A	N/A	Flare Type RT	N/A
N/A	Flare Slope LT (%)	N/A	N/A	Flare Slope RT (%)	N/A
N/A	Flare Traversable LT?	N/A	N/A	Flare Traversable RT?	N/A
N/A	Landing Length (in)	N/A	N/A	DWS Provided?	N/A
N/A	Landing Width (in)	N/A	N/A	DWS Contrast?	N/A
N/A	Landing Slope (%)	N/A	N/A	DWS Length (in)	N/A
N/A	Landing X Slope (%)	N/A	N/A	DWS Full Width?	N/A
N/A	Landing Curb? (Y/N)	N/A	N/A	DWS Offset (in)	N/A
N/A	Shared Landing?	N/A			
N/A	Gutter Ponding?	N/A	N/A	Gutter Slope (%)	N/A
N/A	Gutter Lip Ht (in)	N/A	N/A	Gutter X Slope (%)	N/A
N/A	Painted X Walk1?	No	N/A	Painted X Walk2?	N/A
	X Walk 1 Direction	To E		X Walk 2 Direction	N/A
N/A	X Walk 1 Width (in)	N/A	N/A	X Walk 2 Width (in)	N/A
	X Walk 1 Slope (%)	2.8		X Walk 2 Slope (%)	N/A
	X Walk 1 X Slope (%)	0.7		X Walk 2 X Slope (%)	N/A

N/A	Ramp inside XWalk1?	N/A	N/A	Ramp inside XWalk2?	N/A
	Road Slope (%)	N/A	N/A	Clear Space?	N/A
	Road X Slope (%)	N/A	N/A	Clear Space to XWalk (in)	N/A
N/A	Any Obstructions?	N/A	N/A	Storm Grate/Utility Hazard?	N/A
	Obstruction Type			Storm Grate/Utility Type	
		N/A			N/A
			Yes	Surface Condition? (G/P)	Good

**Remove & Replace Entire Ramp.**

Total Cost: \$ 1850.00
