Access Compliance Report

Public Rights-of-Way

(Curb Ramps)

Intersection ID: 15813	Main Street: QUEENS_RD_WEST	Cross Street: ROLSTON_DR	Location: S
ADA ID: 75FE8CDAF19A	Ramp Type: MedianPerp	Initial Pass/Fail: Fail	Overall Compliance: No
Severity Score: 12.5			
Codes/Mitigation Info/Possible Solution		Field Measurements/Component Compliance

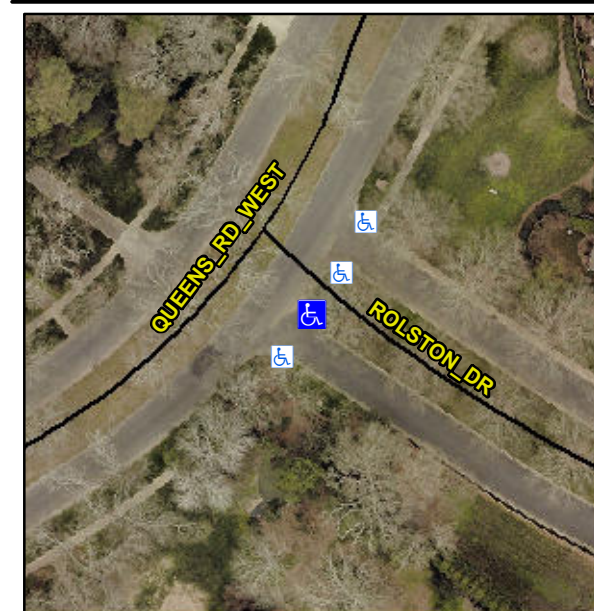
Not Found, R304.2.2

Compliance	Description	Data	Compliance	Description	Data
N/A	Ramp Length (in)	48.0	No	Ramp Slope (%)	9.8
Yes	Ramp Width (in)	48.0	Yes	Ramp XSlope (%)	1.0
N/A	Flare Type LT	N/A	N/A	Flare Type RT	N/A
N/A	Flare Slope LT (%)	N/A	N/A	Flare Slope RT (%)	N/A
N/A	Flare Traversable LT?	N/A	N/A	Flare Traversable RT?	N/A
N/A	Landing Length (in)	N/A	N/A	DWS Provided?	N/A
N/A	Landing Width (in)	N/A	N/A	DWS Contrast?	N/A
N/A	Landing Slope (%)	N/A	N/A	DWS Length (in)	N/A
N/A	Landing X Slope (%)	N/A	N/A	DWS Full Width?	N/A
N/A	Landing Curb? (Y/N)	N/A	N/A	DWS Offset (in)	N/A
N/A	Shared Landing?	N/A			
N/A	Gutter Ponding?	N/A	N/A	Gutter Slope (%)	N/A
N/A	Gutter Lip Ht (in)	N/A	N/A	Gutter X Slope (%)	N/A
N/A	Painted X Walk1?	No	N/A	Painted X Walk2?	N/A
	X Walk 1 Direction	To SW		X Walk 2 Direction	N/A
N/A	X Walk 1 Width (in)	N/A	N/A	X Walk 2 Width (in)	N/A
	X Walk 1 Slope (%)	1.5		X Walk 2 Slope (%)	N/A
	X Walk 1 X Slope (%)	3.1		X Walk 2 X Slope (%)	N/A

N/A	Ramp inside XWalk1?	N/A	N/A	Ramp inside XWalk2?	N/A
	Road Slope (%)	N/A	N/A	Clear Space?	N/A
	Road X Slope (%)	N/A	N/A	Clear Space to XWalk (in)	N/A
N/A	Any Obstructions?	N/A	N/A	Storm Grate/Utility Hazard?	N/A
	Obstruction Type			Storm Grate/Utility Type	
		N/A			N/A
			Yes	Surface Condition? (G/P)	Good

Possible Solutions:

Remove & Replace Entire Ramp.
