Access Compliance Report

Public Rights-of-Way

(Curb Ramps)

Intersection ID: 27741	Main Street: BALLANTYNE_COUNTRY_CLUB_DR	Cross Street: COYLE_CR	Location: S
ADA ID: 75FFF5054EE0	Ramp Type: Perp	Initial Pass/Fail: Fail	Overall Compliance: No
		Severity Score: 25

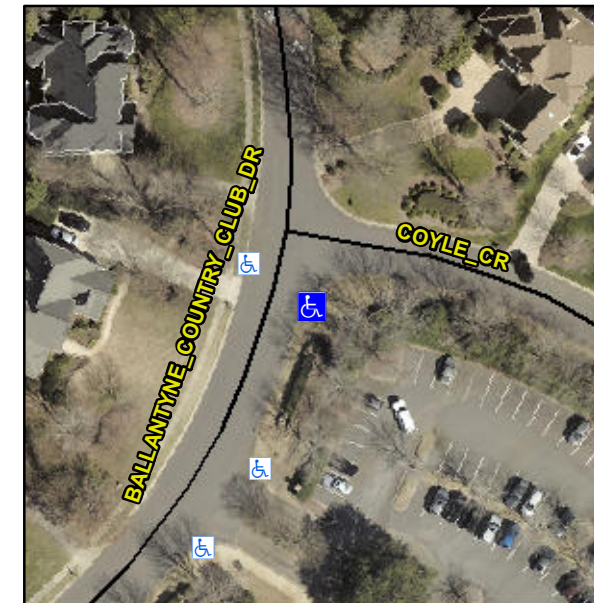
Not Found, R304.2.2, R304.5.3

Compliance	Description	Data	Compliance	Description	Data
N/A	Ramp Length (in)	175.0	No	Ramp Slope (%)	10.0
Yes	Ramp Width (in)	48.0	No	Ramp XSlope (%)	5.9
N/A	Flare Type LT	N/A	N/A	Flare Type RT	N/A
N/A	Flare Slope LT (%)	N/A	N/A	Flare Slope RT (%)	N/A
N/A	Flare Traversable LT?	N/A	N/A	Flare Traversable RT?	N/A
N/A	Landing Length (in)	N/A	N/A	DWS Provided?	N/A
N/A	Landing Width (in)	N/A	N/A	DWS Contrast?	N/A
N/A	Landing Slope (%)	N/A	N/A	DWS Length (in)	N/A
N/A	Landing X Slope (%)	N/A	N/A	DWS Full Width?	N/A
N/A	Landing Curb? (Y/N)	N/A	N/A	DWS Offset (in)	N/A
N/A	Shared Landing?	N/A			
N/A	Gutter Ponding?	N/A	N/A	Gutter Slope (%)	N/A
N/A	Gutter Lip Ht (in)	N/A	N/A	Gutter X Slope (%)	N/A
N/A	Painted X Walk1?	No	N/A	Painted X Walk2?	N/A
	X Walk 1 Direction	To NW		X Walk 2 Direction	N/A
N/A	X Walk 1 Width (in)	N/A	N/A	X Walk 2 Width (in)	N/A
	X Walk 1 Slope (%)	6.9		X Walk 2 Slope (%)	N/A
	X Walk 1 X Slope (%)	3.4		X Walk 2 X Slope (%)	N/A

N/A	Ramp inside XWalk1?	N/A	N/A	Ramp inside XWalk2?	N/A
	Road Slope (%)	N/A	N/A	Clear Space?	N/A
	Road X Slope (%)	N/A	N/A	Clear Space to XWalk (in)	N/A
N/A	Any Obstructions?	N/A	N/A	Storm Grate/Utility Hazard?	N/A
	Obstruction Type			Storm Grate/Utility Type	
		N/A			N/A
			Yes	Surface Condition? (G/P)	Good

Remove & Replace Entire Ramp.
