# Access Compliance Report

## Public Rights-of-Way

### (Curb Ramps)

Intersection ID: 24614	Main Street: BECKMORE_PL	Cross Street: PINEVILLE-MATTHEWS_RD	Location:	S
ADA ID: 7603E6C33AE6	Ramp Type: Combination1Diag	Initial Pass/Fail: Fail	Overall Compliance: No	Severity Score: 0

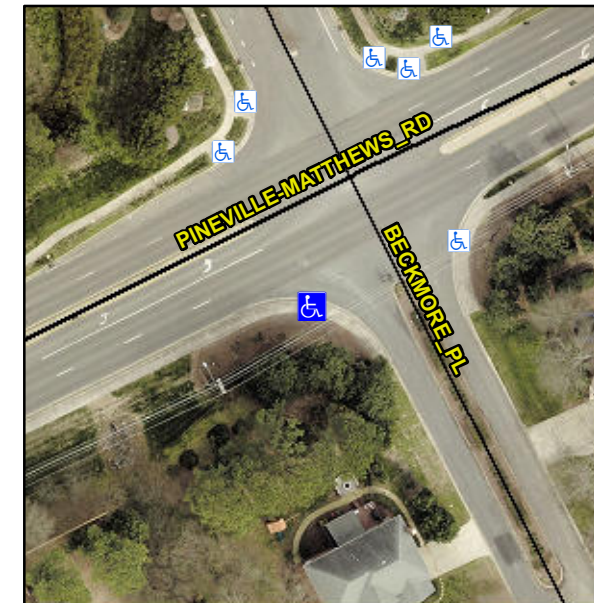
**DWS NAILS EXPOSED**

**R304.5.1, R304.5.1, R304.2.2**

Compliance	Description	Data	Compliance	Description	Data
N/A	Ramp Length LT (in)	41.0	N/A	Ramp Length RT (in)	41.5
Yes	Ramp Width LT (in)	48.0	No	Ramp Width RT (in)	47.0
Yes	Ramp Slope LT (%)	5.7	Yes	Ramp Slope RT (%)	6.6
Yes	Ramp XSlope LT (%)	0.6	Yes	Ramp XSlope RT (%)	0.9
N/A	Ramp Length (in)	24.0	No	Ramp Slope (%)	8.4
No	Ramp Width (in)	45.5	Yes	Ramp XSlope (%)	1.5
N/A	Flare Type LT	N/A	N/A	Flare Type RT	N/A
N/A	Flare Slope LT (%)	N/A	N/A	Flare Slope RT (%)	N/A
N/A	Flare Traversable LT?	N/A	N/A	Flare Traversable RT?	N/A
N/A	Landing Length (in)	N/A	N/A	DWS Provided?	N/A
N/A	Landing Width (in)	N/A	N/A	DWS Contrast?	N/A
N/A	Landing Slope (%)	N/A	N/A	DWS Length (in)	N/A
N/A	Landing X Slope (%)	N/A	N/A	DWS Full Width?	N/A
N/A	Landing Curb? (Y/N)	N/A	N/A	DWS Offset (in)	N/A
N/A	Shared Landing?	N/A			
N/A	Gutter Ponding?	N/A	N/A	Gutter Slope (%)	N/A
N/A	Gutter Lip Ht (in)	N/A	N/A	Gutter X Slope (%)	N/A
N/A	Painted X Walk1?	No	N/A	Painted X Walk2?	No

**Remove & Replace Curb Ramp With Two New Directional Ramps or Equivalent.**
