# Access Compliance Report

## Public Rights-of-Way

### (Curb Ramps)

Intersection ID: 19877	Main Street: ARUNDEL_DR	Cross Street: FAIRVIEW_RD	Location: SE
ADA ID: 7614011CB09C	Ramp Type: PerpDiag	Initial Pass/Fail: Fail	Overall Compliance: No
		Severity Score: 12.5

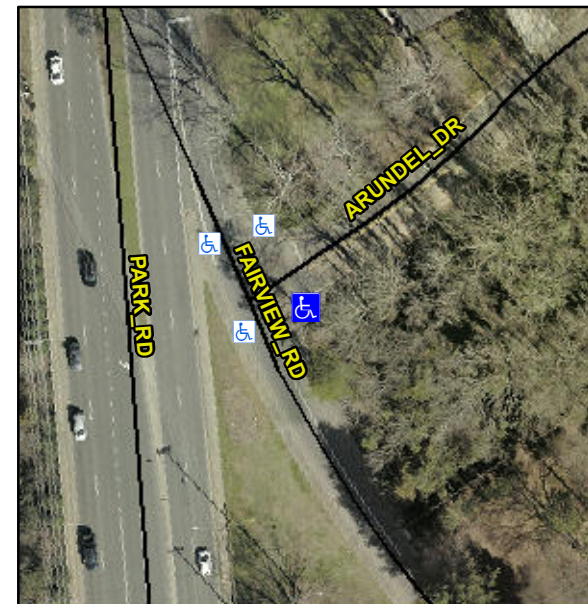
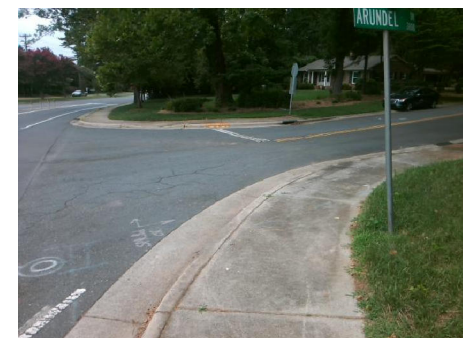
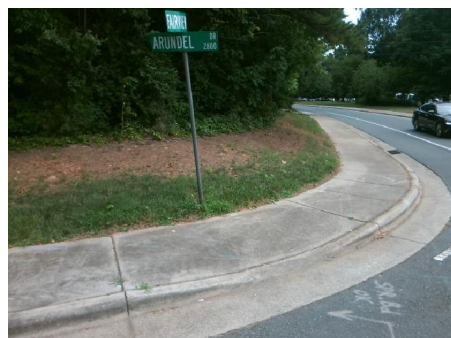
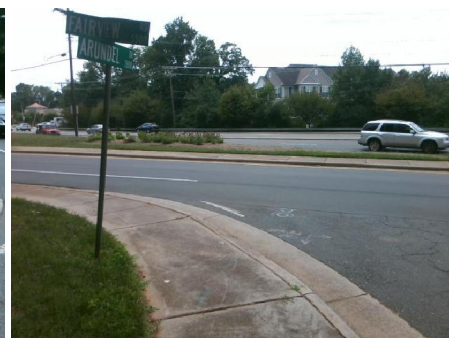
**Not Found, R304.2.2**

Compliance	Description	Data	Compliance	Description	Data
N/A	Ramp Length (in)	59.0	No	Ramp Slope (%)	10.5
Yes	Ramp Width (in)	48.0	Yes	Ramp XSlope (%)	0.1
N/A	Flare Type LT	N/A	N/A	Flare Type RT	N/A
N/A	Flare Slope LT (%)	N/A	N/A	Flare Slope RT (%)	N/A
N/A	Flare Traversable LT?	N/A	N/A	Flare Traversable RT?	N/A
N/A	Landing Length (in)	N/A	N/A	DWS Provided?	N/A
N/A	Landing Width (in)	N/A	N/A	DWS Contrast?	N/A
N/A	Landing Slope (%)	N/A	N/A	DWS Length (in)	N/A
N/A	Landing X Slope (%)	N/A	N/A	DWS Full Width?	N/A
N/A	Landing Curb? (Y/N)	N/A	N/A	DWS Offset (in)	N/A
N/A	Shared Landing?	N/A			
N/A	Gutter Ponding?	N/A	N/A	Gutter Slope (%)	N/A
N/A	Gutter Lip Ht (in)	N/A	N/A	Gutter X Slope (%)	N/A
N/A	Painted X Walk1?	No	N/A	Painted X Walk2?	No
	X Walk 1 Direction	To N		X Walk 2 Direction	To W
N/A	X Walk 1 Width (in)	N/A	N/A	X Walk 2 Width (in)	N/A
	X Walk 1 Slope (%)	0.5		X Walk 2 Slope (%)	1.4
	X Walk 1 X Slope (%)	0.3		X Walk 2 X Slope (%)	3.7

N/A	Ramp inside XWalk1?	N/A	N/A	Ramp inside XWalk2?	N/A
	Road Slope (%)	2.0	N/A	Clear Space?	N/A
	Road X Slope (%)	6.3	N/A	Clear Space to XWalk (in)	N/A
N/A	Any Obstructions?	N/A	N/A	Storm Grate/Utility Hazard?	N/A
	Obstruction Type			Storm Grate/Utility Type	
		N/A			N/A
			Yes	Surface Condition? (G/P)	Good

**Remove & Replace Curb Ramp With Two New Directional Ramps or Equivalent.**
