# Access Compliance Report

## Public Rights-of-Way

### (Curb Ramps)

Intersection ID: 25474	Main Street: MCMULLEN_CREEK_PY	Cross Street: JOHNSTON_RD	Location: N
ADA ID: 761C567699A0	Ramp Type: PerpDiag	Initial Pass/Fail: Fail	Overall Compliance: No
			Severity Score: 13.75

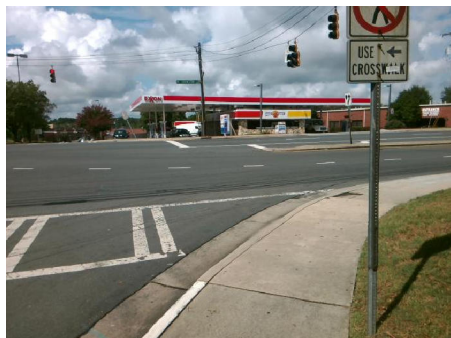
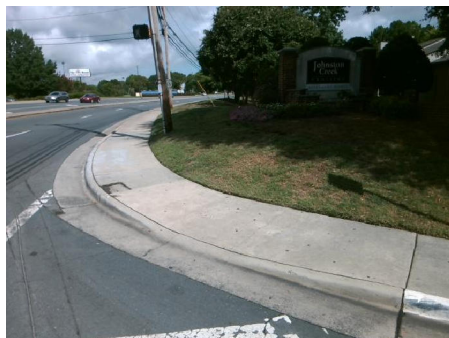
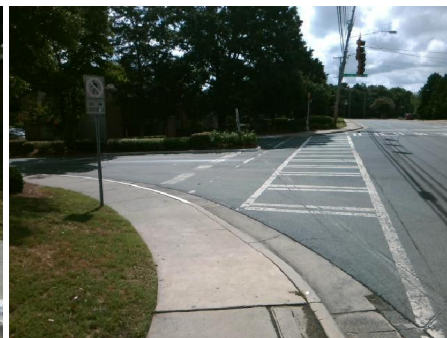
**Not Found, R304.2.2, R304.5.3**

Compliance	Description	Data	Compliance	Description	Data
N/A	Ramp Length (in)	60.0	No	Ramp Slope (%)	8.7
Yes	Ramp Width (in)	48.0	No	Ramp XSlope (%)	4.0
N/A	Flare Type LT	N/A	N/A	Flare Type RT	N/A
N/A	Flare Slope LT (%)	N/A	N/A	Flare Slope RT (%)	N/A
N/A	Flare Traversable LT?	N/A	N/A	Flare Traversable RT?	N/A
N/A	Landing Length (in)	N/A	N/A	DWS Provided?	N/A
N/A	Landing Width (in)	N/A	N/A	DWS Contrast?	N/A
N/A	Landing Slope (%)	N/A	N/A	DWS Length (in)	N/A
N/A	Landing X Slope (%)	N/A	N/A	DWS Full Width?	N/A
N/A	Landing Curb? (Y/N)	N/A	N/A	DWS Offset (in)	N/A
N/A	Shared Landing?	N/A			
N/A	Gutter Ponding?	N/A	N/A	Gutter Slope (%)	N/A
N/A	Gutter Lip Ht (in)	N/A	N/A	Gutter X Slope (%)	N/A
N/A	Painted X Walk1?	No	N/A	Painted X Walk2?	Yes
	X Walk 1 Direction	To SW		X Walk 2 Direction	To SE
N/A	X Walk 1 Width (in)	N/A	N/A	X Walk 2 Width (in)	105.0
	X Walk 1 Slope (%)	3.9		X Walk 2 Slope (%)	1.0
	X Walk 1 X Slope (%)	1.2		X Walk 2 X Slope (%)	2.6

N/A	Ramp inside XWalk1?	N/A	N/A	Ramp inside XWalk2?	Yes
	Road Slope (%)	2.5	N/A	Clear Space?	N/A
	Road X Slope (%)	1.1	N/A	Clear Space to XWalk (in)	N/A
N/A	Any Obstructions?	N/A	N/A	Storm Grate/Utility Hazard?	N/A
	Obstruction Type			Storm Grate/Utility Type	
		N/A			N/A
			Yes	Surface Condition? (G/P)	Good

**Remove & Replace Curb Ramp With Two New Directional Ramps or Equivalent.**
