Access Compliance Report

Public Rights-of-Way

(Curb Ramps)

Intersection ID: 47275	Main Street: CARRINGTON_FOREST_LN	Cross Street: GREYSTONE_PARK_LN	Location: SW
ADA ID: 7626824F7892	Ramp Type: BlendTrans1	Initial Pass/Fail: Fail	Overall Compliance: No
Severity Score: 8.75			
Codes/Mitigation Info/Possible Solution		Field Measurements/Component Compliance

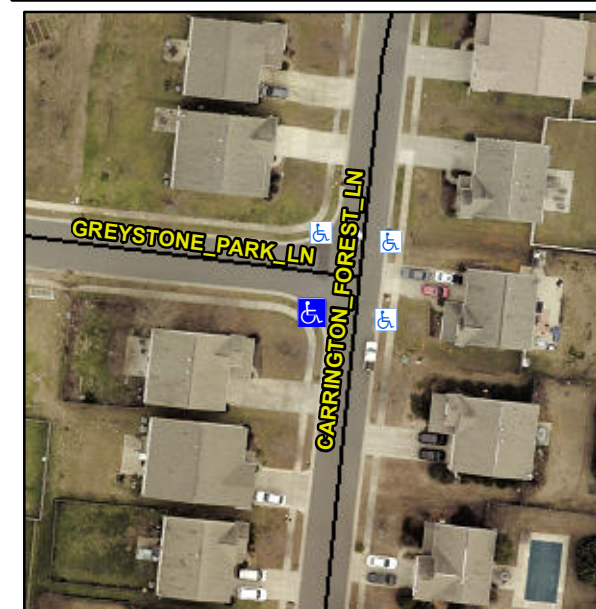
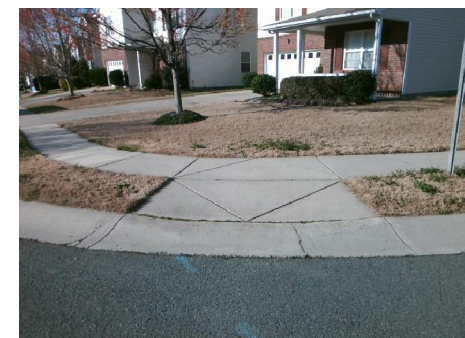
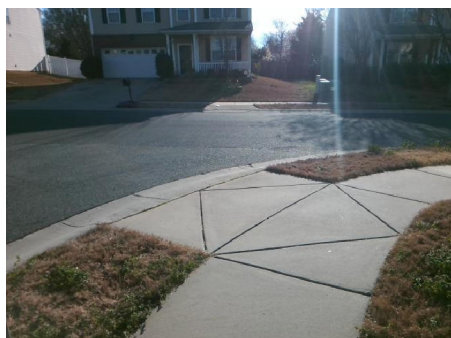
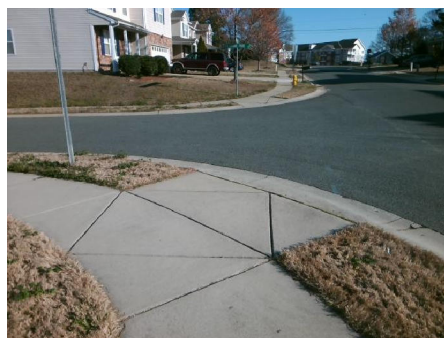
Not Found, R304.5.1

Compliance	Description	Data	Compliance	Description	Data
N/A	Ramp Length (in)	49.8	Yes	BlendTrans Slope (%)	3.4
No	Ramp Width (in)	46.0	Yes	BlendTrans XSlope (%)	0.2
N/A	Flare Type LT	N/A	N/A	Flare Type RT	N/A
N/A	Flare Slope LT (%)	N/A	N/A	Flare Slope RT (%)	N/A
N/A	Flare Traversable LT?	N/A	N/A	Flare Traversable RT?	N/A
N/A	Landing Length (in)	N/A	N/A	DWS Provided?	N/A
N/A	Landing Width (in)	N/A	N/A	DWS Contrast?	N/A
N/A	Landing Slope (%)	N/A	N/A	DWS Length (in)	N/A
N/A	Landing X Slope (%)	N/A	N/A	DWS Full Width?	N/A
N/A	Landing Curb? (Y/N)	N/A	N/A	DWS Offset (in)	N/A
N/A	Shared Landing?	N/A			
N/A	Gutter Ponding?	N/A	N/A	Gutter Slope (%)	N/A
N/A	Gutter Lip Ht (in)	N/A	N/A	Gutter X Slope (%)	N/A
N/A	Painted X Walk1?	No	N/A	Painted X Walk2?	No
	X Walk 1 Direction	To E		X Walk 2 Direction	To N
	X Walk 1 Width (in)	N/A		X Walk 2 Width (in)	N/A
	X Walk 1 Slope (%)	0.6		X Walk 2 Slope (%)	2.9
	X Walk 1 X Slope (%)	3.5		X Walk 2 X Slope (%)	2.4

N/A	Ramp inside XWalk1?	N/A	N/A	Ramp inside XWalk2?	N/A
	Road Slope (%)	1.7		Clear Space?	N/A
	Road X Slope (%)	3.3	N/A	Clear Space to XWalk (in)	N/A
N/A	Any Obstructions?	N/A	N/A	Storm Grate/Utility Hazard?	N/A
	Obstruction Type			Storm Grate/Utility Type	
		N/A			N/A
			Yes	Surface Condition? (G/P)	Good
			No	Curb Slope (%)	11.1

Possible Solutions:

Remove & Replace Curb Ramp With Two New Directional Ramps or Equivalent.
