Access Compliance Report

Public Rights-of-Way

(Curb Ramps)

Intersection ID: 42783	Main Street: OLD_STONE_CROSSING_DR	Cross Street: SAWMILL_TRACE_DR	Location: SE
ADA ID: 766FA0D9E6B2	Ramp Type: PerpDiag	Initial Pass/Fail: Fail	Overall Compliance: No
Severity Score: 35			
Codes/Mitigation Info/Possible Solution		Field Measurements/Component Compliance

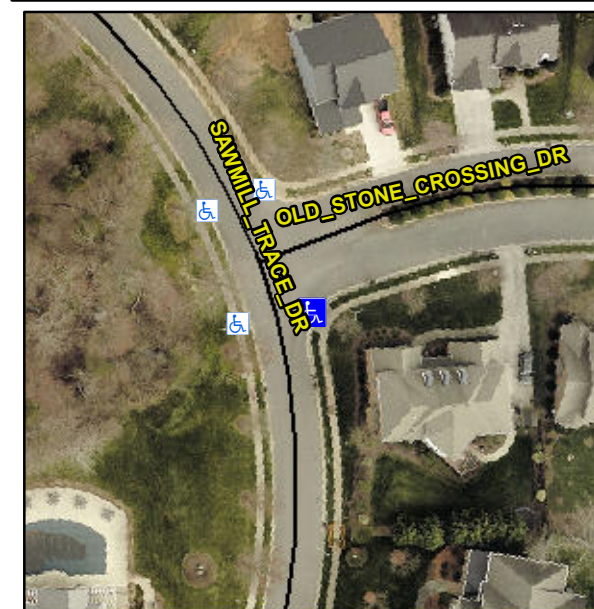
Not Found, R304.5.1, R304.2.2, R304.5.3

Compliance	Description	Data	Compliance	Description	Data
N/A	Ramp Length (in)	48.5	No	Ramp Slope (%)	14.1
No	Ramp Width (in)	45.5	No	Ramp XSlope (%)	4.2
N/A	Flare Type LT	N/A	N/A	Flare Type RT	N/A
N/A	Flare Slope LT (%)	N/A	N/A	Flare Slope RT (%)	N/A
N/A	Flare Traversable LT?	N/A	N/A	Flare Traversable RT?	N/A
N/A	Landing Length (in)	N/A	N/A	DWS Provided?	N/A
N/A	Landing Width (in)	N/A	N/A	DWS Contrast?	N/A
N/A	Landing Slope (%)	N/A	N/A	DWS Length (in)	N/A
N/A	Landing X Slope (%)	N/A	N/A	DWS Full Width?	N/A
N/A	Landing Curb? (Y/N)	N/A	N/A	DWS Offset (in)	N/A
N/A	Shared Landing?	N/A			
N/A	Gutter Ponding?	N/A	N/A	Gutter Slope (%)	N/A
N/A	Gutter Lip Ht (in)	N/A	N/A	Gutter X Slope (%)	N/A
N/A	Painted X Walk1?	No	N/A	Painted X Walk2?	No
	X Walk 1 Direction	To N		X Walk 2 Direction	To W
N/A	X Walk 1 Width (in)	N/A	N/A	X Walk 2 Width (in)	N/A
	X Walk 1 Slope (%)	4.3		X Walk 2 Slope (%)	0.5
	X Walk 1 X Slope (%)	0.1		X Walk 2 X Slope (%)	3.8

N/A	Ramp inside XWalk1?	N/A	N/A	Ramp inside XWalk2?	N/A
	Road Slope (%)	1.5	N/A	Clear Space?	N/A
	Road X Slope (%)	3.1	N/A	Clear Space to XWalk (in)	N/A
N/A	Any Obstructions?	N/A	N/A	Storm Grate/Utility Hazard?	N/A
	Obstruction Type			Storm Grate/Utility Type	
		N/A			N/A
			Yes	Surface Condition? (G/P)	Good

Possible Solutions:

Remove & Replace Curb Ramp With Two New Directional Ramps or Equivalent.
