Access Compliance Report

Public Rights-of-Way

(Curb Ramps)

Intersection ID: 11174	Main Street: HARRISBURG_RD	Cross Street: TIMBERTOP_LN	Location: W
ADA ID: 7672CB813E65	Ramp Type: PerpDiag	Initial Pass/Fail: Fail	Overall Compliance: No
Severity Score: 36.25			
Codes/Mitigation Info/Possible Solution		Field Measurements/Component Compliance

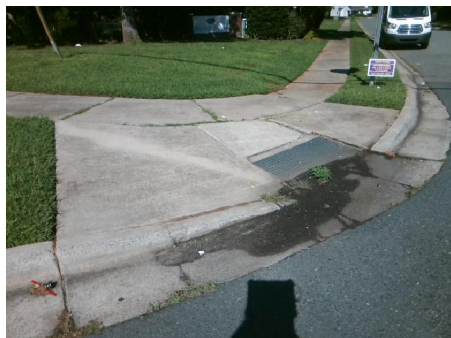
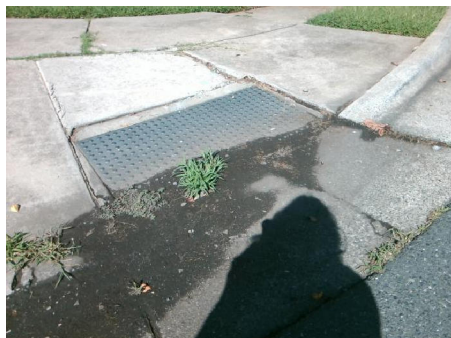
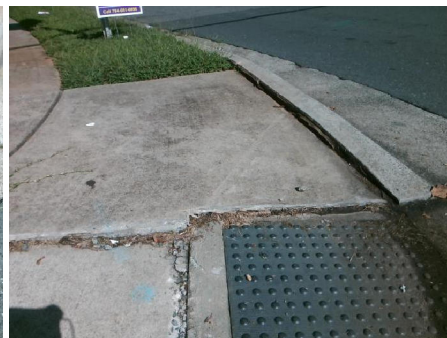
R304.5.1, R304.2.2, R302.7

Compliance	Description	Data	Compliance	Description	Data
N/A	Ramp Length (in)	61.0	No	Ramp Slope (%)	10.6
No	Ramp Width (in)	40.5	Yes	Ramp XSlope (%)	0.4
N/A	Flare Type LT	N/A	N/A	Flare Type RT	N/A
N/A	Flare Slope LT (%)	N/A	N/A	Flare Slope RT (%)	N/A
N/A	Flare Traversable LT?	N/A	N/A	Flare Traversable RT?	N/A
N/A	Landing Length (in)	N/A	N/A	DWS Provided?	N/A
N/A	Landing Width (in)	N/A	N/A	DWS Contrast?	N/A
N/A	Landing Slope (%)	N/A	N/A	DWS Length (in)	N/A
N/A	Landing X Slope (%)	N/A	N/A	DWS Full Width?	N/A
N/A	Landing Curb? (Y/N)	N/A	N/A	DWS Offset (in)	N/A
N/A	Shared Landing?	N/A			
N/A	Gutter Ponding?	Yes	N/A	Gutter Slope (%)	N/A
N/A	Gutter Lip Ht (in)	N/A	N/A	Gutter X Slope (%)	N/A
N/A	Painted X Walk1?	No	N/A	Painted X Walk2?	No
	X Walk 1 Direction	To SE		X Walk 2 Direction	To NE
N/A	X Walk 1 Width (in)	N/A	N/A	X Walk 2 Width (in)	N/A
	X Walk 1 Slope (%)	4.8		X Walk 2 Slope (%)	2.1
	X Walk 1 X Slope (%)	3.1		X Walk 2 X Slope (%)	3.6

N/A	Ramp inside XWalk1?	N/A	N/A	Ramp inside XWalk2?	N/A
	Road Slope (%)	1.1	N/A	Clear Space?	N/A
	Road X Slope (%)	3.7	N/A	Clear Space to XWalk (in)	N/A
N/A	Any Obstructions?	N/A	N/A	Storm Grate/Utility Hazard?	N/A
	Obstruction Type			Storm Grate/Utility Type	
		N/A			N/A
		No		Surface Condition? (G/P)	Poor

Possible Solutions:

Remove & Replace Curb Ramp With Two New Directional Ramps or Equivalent.
