Access Compliance Report

Public Rights-of-Way

(Curb Ramps)

Intersection ID: 30248	Main Street: OLD_IRONSIDE_DR	Cross Street: WOLVERINE_CT	Location: SE
ADA ID: 768849B7DD2D	Ramp Type: PerpDiag	Initial Pass/Fail: Fail	Overall Compliance: No
		Severity Score: 50

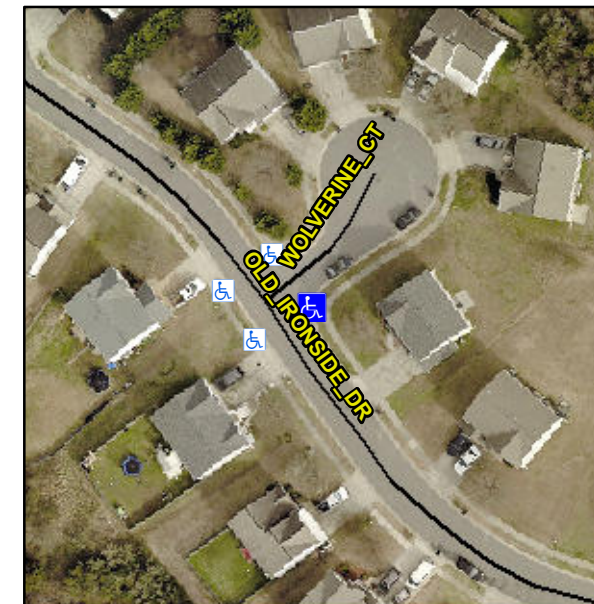
Not Found, R304.2.2, R304.5.3

Compliance	Description	Data	Compliance	Description	Data
N/A	Ramp Length (in)	46.0	No	Ramp Slope (%)	12.1
Yes	Ramp Width (in)	55.5	No	Ramp XSlope (%)	11.2
N/A	Flare Type LT	N/A	N/A	Flare Type RT	N/A
N/A	Flare Slope LT (%)	N/A	N/A	Flare Slope RT (%)	N/A
N/A	Flare Traversable LT?	N/A	N/A	Flare Traversable RT?	N/A
N/A	Landing Length (in)	N/A	N/A	DWS Provided?	N/A
N/A	Landing Width (in)	N/A	N/A	DWS Contrast?	N/A
N/A	Landing Slope (%)	N/A	N/A	DWS Length (in)	N/A
N/A	Landing X Slope (%)	N/A	N/A	DWS Full Width?	N/A
N/A	Landing Curb? (Y/N)	N/A	N/A	DWS Offset (in)	N/A
N/A	Shared Landing?	N/A			
N/A	Gutter Ponding?	N/A	N/A	Gutter Slope (%)	N/A
N/A	Gutter Lip Ht (in)	N/A	N/A	Gutter X Slope (%)	N/A
N/A	Painted X Walk1?	No	N/A	Painted X Walk2?	No
	X Walk 1 Direction	To NW		X Walk 2 Direction	To SW
N/A	X Walk 1 Width (in)	N/A	N/A	X Walk 2 Width (in)	N/A
	X Walk 1 Slope (%)	4.6		X Walk 2 Slope (%)	5.0
	X Walk 1 X Slope (%)	7.3		X Walk 2 X Slope (%)	6.0

N/A	Ramp inside XWalk1?	N/A	N/A	Ramp inside XWalk2?	N/A
	Road Slope (%)	8.5	N/A	Clear Space?	N/A
	Road X Slope (%)	1.2	N/A	Clear Space to XWalk (in)	N/A
N/A	Any Obstructions?	N/A	N/A	Storm Grate/Utility Hazard?	N/A
	Obstruction Type			Storm Grate/Utility Type	
		N/A			N/A
			Yes	Surface Condition? (G/P)	Good

Remove & Replace Curb Ramp With Two New Directional Ramps or Equivalent.

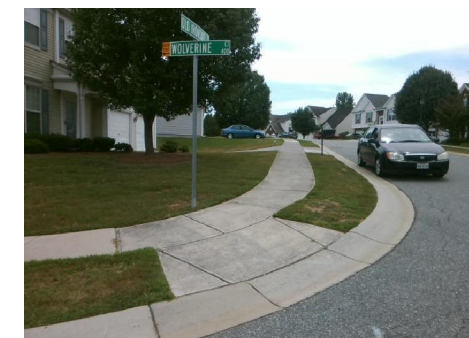
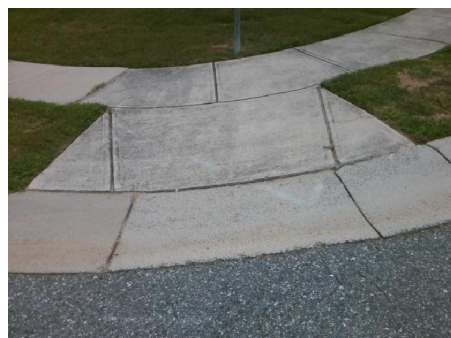
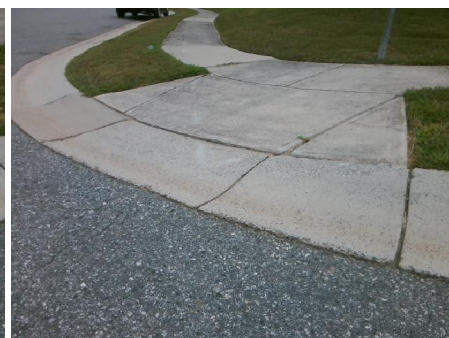
Street 1 Name **WOLVERINE CT**
 Stop Condition-Street 2 **StopSign**
 Street 2 Name **OLD IRONSIDE DR**
 Stop Condition-Street 1 **None**
