Access Compliance Report Public Rights-of-Way (Curb Ramps)

Intersection ID: 52449 Main Street: TRANQUIL_OAK_PL Cross Street: PAT_GARRETT_ST Location: NE **Overall Compliance: No** ADA ID: 768CED0677BC Ramp Type: Directional1 Initial Pass/Fail: Fail Severity Score: 13.75

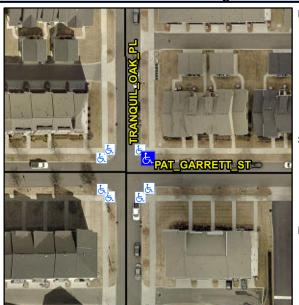
Compliance Description		Data	Compl	iance	Description	Data
N/A	Ramp Length (in)	70.0	N/A	Grad	e Break?	N/A
Yes	Ramp Width (in)	67.0	N/A	Grad	e Break Slope (%)	0.0
No	Ramp Slope (%)	9.8	N/A	Grad	e Break XSlope (%)	0.0
Yes	Ramp XSlope (%)	3.0				
N/A	Flare Type LT	N/A	N/A	Flare	Type RT	N/A
N/A	Flare Slope LT (%)	N/A	N/A	Flare	Slope RT (%)	0.0
N/A	Flare Traversable LT?	N/A	N/A	Flare	Traversable RT?	N/A
N/A	Landing Length (in)	0.0	N/A	DWS	Provided?	N/A
N/A	Landing Width (in)	0.0	N/A	DWS	Contrast?	N/A
N/A	Landing Slope (%)	0.0	N/A	DWS	Length (in)	N/A
N/A	Landing X Slope (%)	0.0	N/A	DWS	Full Width?	N/A
N/A	Landing Curb? (Y/N)	N/A	N/A	DWS	Offset LT (in)	N/A
N/A	Shared Landing?	N/A	N/A	DWS	Offset RT (in)	N/A
N/A	Gutter Ponding?	0.0	N/A	Gutte	er Slope (%)	N/A
N/A	Gutter Lip Ht (in)	0.0	N/A	Gutte	r X Slope (%)	N/A
N/A	Painted X Walk1?	No		Road	Slope (%)	1.6
	X Walk 1 Direction	To S		Road	X Slope (%)	3.6
	X Walk 1 Width (in)	N/A		Clear	Space?	N/A

X Walk 1 Slope (%)	1.6	N/A	Clear	Space to XWalk (in)	N/A
	X Walk 1 X Slope (%)	3.6	N/A	Storn	n Grate/Utility Hazard?	N/A
N/A	Ramp inside XWalk1?	N/A		Storn	n Grate/Utility Type	
N/A	Any Obstructions?	N/A				N/A
	Obstruction Type		Yes	Surfa	ce Condition? (G/P)	Good
		N/A	N/A	Curb	Slope (%)	3.2

1	Possible Solutions:
	Remove & Replace Entire Ramp.
-	Surveyor Notes:
()	N/A
	PROW/ADA:
The second second second	R304.2.2
