Access Compliance Report Public Rights-of-Way (Curb Ramps)

Intersection ID: 29396 Main Street: FORWOOD_CT Cross Street: SILVERFIELD_LN Location: SW **Overall Compliance: No Severity Score:** ADA ID: 768D3E60CB91 Ramp Type: PerpDiag Initial Pass/Fail: Fail 25

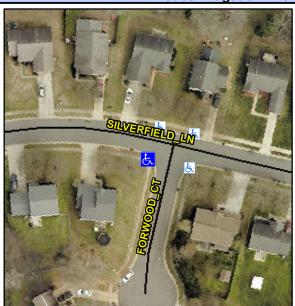
Field Measurements/Component Compliance								
Compliance Description		Data	Comp	liance Description	Data			
N/A	Ramp Length (in)	39.0	No	Ramp Slope (%)	8.8			
Yes	Ramp Width (in)	48.0	No	Ramp XSlope (%)	6.6			
N/A	Flare Type LT	N/A	N/A	Flare Type RT	N/A			
N/A	Flare Slope LT (%)	N/A	N/A	Flare Slope RT (%)	N/A			
N/A	Flare Traversable LT?	N/A	N/A	Flare Traversable RT?	N/A			
N/A	Landing Length (in)	N/A	N/A	DWS Provided?	N/A			
N/A	Landing Width (in)	N/A	N/A	DWS Contrast?	N/A			
N/A	Landing Slope (%)	N/A	N/A	DWS Length (in)	N/A			
N/A	Landing X Slope (%)	N/A	N/A	DWS Full Width?	N/A			
N/A	Landing Curb? (Y/N)	N/A	N/A	DWS Offset (in)	N/A			
N/A	Shared Landing?	N/A						
N/A	Gutter Ponding?	N/A	N/A	Gutter Slope (%)	N/A			
N/A	Gutter Lip Ht (in)	0.5	N/A	Gutter X Slope (%)	N/A			
N/A	Painted X Walk1?	No	N/A	Painted X Walk2?	No			
	X Walk 1 Direction	То Е		X Walk 2 Direction	To N			
N/A	X Walk 1 Width (in)	N/A	N/A	X Walk 2 Width (in)	N/A

X Walk 1 Slope (%)	2.3		X Walk 2 Slope (%)	5.2			
	X Walk 1 X Slope (%)	3.1		X Walk 2 X Slope (%)	4.4			
N/A	Ramp inside XWalk1?	N/A	N/A	Ramp inside XWalk2?	N/A			
	Road Slope (%)	5.3	N/A	Clear Space?	N/A			
	Road X Slope (%)	0.1	N/A	Clear Space to XWalk (in)	N/A			
N/A	Any Obstructions?	N/A	N/A	Storm Grate/Utility Hazard?	N/A			
	Obstruction Type			Storm Grate/Utility Type				
		N/A			N/A			
			Yes	Surface Condition? (G/P)	Good

ossible Solution					
Possible Solutions:	9				
Remove & Replace Curb Ramp With					
Two New Directional Ramps or	•				
Equivalent.	ı				
	ı				
	ı				
	I				
Surveyor Notes:	ı				
N/A	ı				
	ı				
	ı				
	ı				
PROW/ADA:	I				
Not Found, R304.2.2, R304.5.3	I
