# Access Compliance Report

## Public Rights-of-Way

### (Curb Ramps)

Intersection ID: 10022060	Main Street: BRYSON_BEND_DR	Cross Street: N/A	Location: SE
ADA ID: 76AC620C8996	Ramp Type: BlendTrans1	Initial Pass/Fail: Fail	Overall Compliance: No
Codes/Mitigation Info/Possible Solution		Field Measurements/Component Compliance	
Severity Score: 12.5

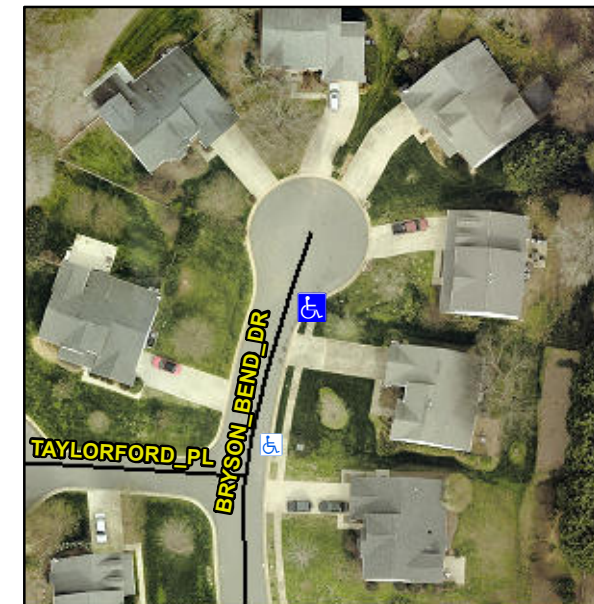
Compliance	Description	Data	Compliance	Description	Data
N/A	Ramp Length (in)	26.0	Yes	BlendTrans Slope (%)	1.5
Yes	Ramp Width (in)	48.0	No	BlendTrans XSlope (%)	5.5
N/A	Flare Type LT	N/A	N/A	Flare Type RT	N/A
N/A	Flare Slope LT (%)	N/A	N/A	Flare Slope RT (%)	N/A
N/A	Flare Traversable LT?	N/A	N/A	Flare Traversable RT?	N/A
N/A	Landing Length (in)	N/A	N/A	DWS Provided?	N/A
N/A	Landing Width (in)	N/A	N/A	DWS Contrast?	N/A
N/A	Landing Slope (%)	N/A	N/A	DWS Length (in)	N/A
N/A	Landing X Slope (%)	N/A	N/A	DWS Full Width?	N/A
N/A	Landing Curb? (Y/N)	N/A	N/A	DWS Offset (in)	N/A
N/A	Shared Landing?	N/A			
N/A	Gutter Ponding?	N/A	N/A	Gutter Slope (%)	N/A
N/A	Gutter Lip Ht (in)	N/A	N/A	Gutter X Slope (%)	N/A
N/A	Painted X Walk1?	No	N/A	Painted X Walk2?	N/A
	X Walk 1 Direction	To NW		X Walk 2 Direction	N/A
	X Walk 1 Width (in)	N/A		X Walk 2 Width (in)	N/A
	X Walk 1 Slope (%)	9.1		X Walk 2 Slope (%)	N/A
	X Walk 1 X Slope (%)	5.2		X Walk 2 X Slope (%)	N/A

N/A	Ramp inside XWalk1?	N/A	N/A	Ramp inside XWalk2?	N/A
	Road Slope (%)	5.2		Clear Space?	N/A
	Road X Slope (%)	9.1	N/A	Clear Space to XWalk (in)	N/A
N/A	Any Obstructions?	N/A	N/A	Storm Grate/Utility Hazard?	N/A
	Obstruction Type			Storm Grate/Utility Type	
		N/A			N/A
			Yes	Surface Condition? (G/P)	Good
			N/A	Curb Slope (%)	5.0

**Remove & Replace Curb Ramp With Two New Directional Ramps or Equivalent.**

**R304.5.3**
