Access Compliance Report Public Rights-of-Way (Curb Ramps)

Intersection ID: 27728 Main Street: BALLANTYNE_COUNTRY_CLUBroxs Street: COYLE_CR Location: NE

ADA ID: 76AEFAE8D057 Ramp Type: Perp Initial Pass/Fail: Fail Overall Compliance: No Severity Score: 26.25

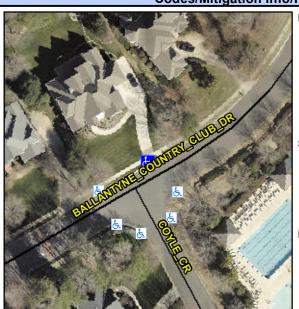
Possible Solutions:	Compliance Description	
Remove & Replace Entire Ramp.	N/A	Ramp Length (in)
	Yes	Ramp Width (in)
1	N/A	Flare Type LT
	N/A	Flare Slope LT (%)
	N/A	Flare Traversable LT?
	N/A	Landing Length (in)
Surveyor Notes:	N/A	Landing Width (in)
N/A	N/A	Landing Slope (%)
	N/A	Landing X Slope (%)
	N/A	Landing Curb? (Y/N)
	N/A	Shared Landing?
PROW/ADA:	N/A	Gutter Ponding?
Not Found, R304.2.2, R304.5.3	N/A	Gutter Lip Ht (in)
	N/A	Painted X Walk1?
1		X Walk 1 Direction
	N/A	X Walk 1 Width (in)
		X Walk 1 Slope (%)
		X Walk 1 X Slope (%)
	N/A	Ramp inside XWalk1?
		Road Slope (%)
		Road X Slope (%)
	N/A	Any Obstructions?
