Access Compliance Report

Public Rights-of-Way

(Curb Ramps)

Intersection ID: 44000	Main Street: ELROSE_PL	Cross Street: GANDER_DR	Location: SE
ADA ID: 76B00273707A	Ramp Type: BlendTrans1	Initial Pass/Fail: Fail	Overall Compliance: No
Severity Score: 12.5			
Codes/Mitigation Info/Possible Solution		Field Measurements/Component Compliance

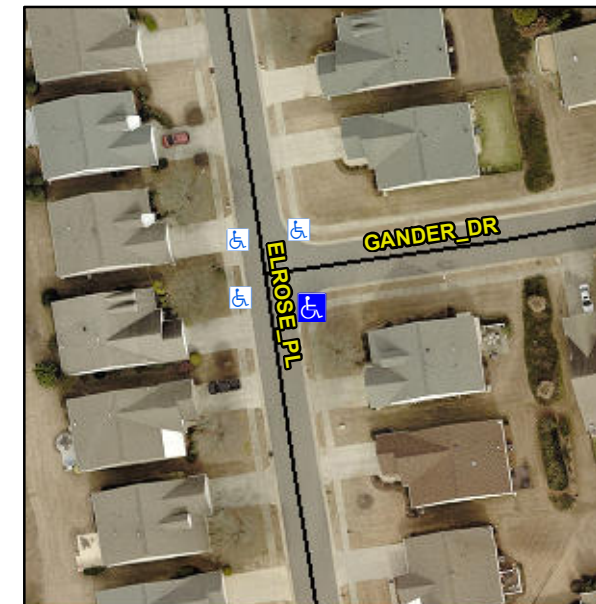
Compliance	Description	Data	Compliance	Description	Data
N/A	Ramp Length (in)	44.0	Yes	BlendTrans Slope (%)	1.1
Yes	Ramp Width (in)	69.0	No	BlendTrans XSlope (%)	6.5
N/A	Flare Type LT	N/A	N/A	Flare Type RT	N/A
N/A	Flare Slope LT (%)	N/A	N/A	Flare Slope RT (%)	N/A
N/A	Flare Traversable LT?	N/A	N/A	Flare Traversable RT?	N/A
N/A	Landing Length (in)	N/A	N/A	DWS Provided?	N/A
N/A	Landing Width (in)	N/A	N/A	DWS Contrast?	N/A
N/A	Landing Slope (%)	N/A	N/A	DWS Length (in)	N/A
N/A	Landing X Slope (%)	N/A	N/A	DWS Full Width?	N/A
N/A	Landing Curb? (Y/N)	N/A	N/A	DWS Offset (in)	N/A
N/A	Shared Landing?	N/A			
N/A	Gutter Ponding?	N/A	N/A	Gutter Slope (%)	N/A
N/A	Gutter Lip Ht (in)	N/A	N/A	Gutter X Slope (%)	N/A
N/A	Painted X Walk1?	No	N/A	Painted X Walk2?	No
	X Walk 1 Direction	To NW		X Walk 2 Direction	To W
	X Walk 1 Width (in)	N/A		X Walk 2 Width (in)	N/A
	X Walk 1 Slope (%)	0.4		X Walk 2 Slope (%)	4.4
	X Walk 1 X Slope (%)	5.3		X Walk 2 X Slope (%)	0.5

N/A	Ramp inside XWalk1?	N/A	N/A	Ramp inside XWalk2?	N/A
	Road Slope (%)	5.8		Clear Space?	N/A
	Road X Slope (%)	1.2	N/A	Clear Space to XWalk (in)	N/A
N/A	Any Obstructions?	N/A	N/A	Storm Grate/Utility Hazard?	N/A
	Obstruction Type			Storm Grate/Utility Type	
		N/A			N/A
			Yes	Surface Condition? (G/P)	Good
			No	Curb Slope (%)	27.7

Possible Solutions:

Remove & Replace Curb Ramp With Two New Directional Ramps or Equivalent.

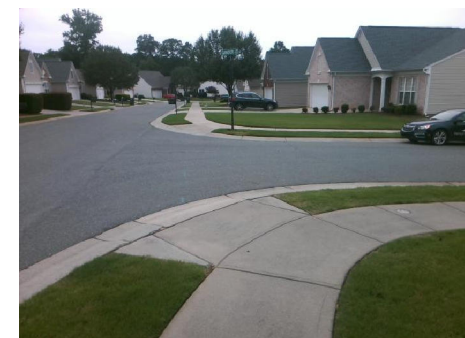
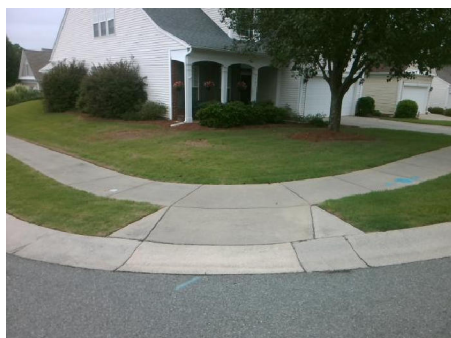
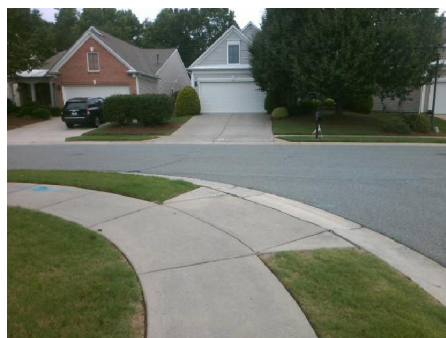
Street 1 Name **GANDER DR**
 Stop Condition-Street 1 **StopSign**
 Street 2 Name **ELROSE PL**
 Stop Condition-Street 2 **None**
