Access Compliance Report

Public Rights-of-Way

(Curb Ramps)

Intersection ID: 20860	Main Street: CROWNPOINT_EXECUTIVE_DR	Cross Street: KREFELD_DR	Location: NE
ADA ID: 76DEF566A98C	Ramp Type: PerpDiag	Initial Pass/Fail: Fail	Overall Compliance: No
		Severity Score: 12.5

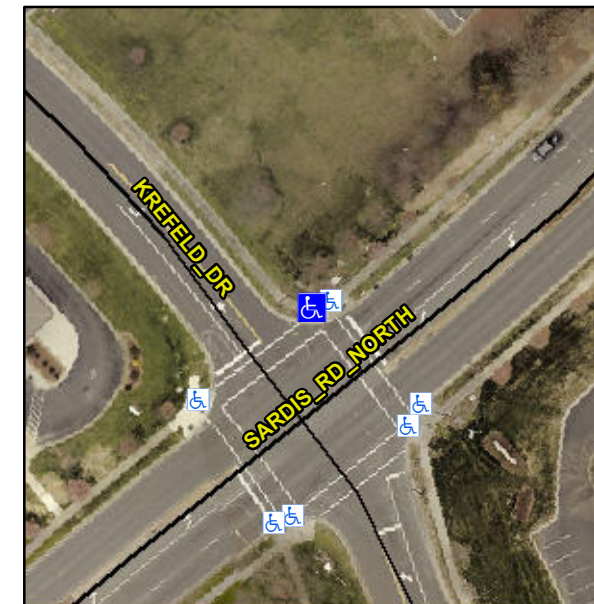
Compliance	Description	Data	Compliance	Description	Data
N/A	Ramp Length (in)	53.0	Yes	Ramp Slope (%)	6.3
Yes	Ramp Width (in)	48.0	No	Ramp XSlope (%)	5.8
N/A	Flare Type LT	N/A	N/A	Flare Type RT	N/A
N/A	Flare Slope LT (%)	N/A	N/A	Flare Slope RT (%)	N/A
N/A	Flare Traversable LT?	N/A	N/A	Flare Traversable RT?	N/A
N/A	Landing Length (in)	N/A	N/A	DWS Provided?	N/A
N/A	Landing Width (in)	N/A	N/A	DWS Contrast?	N/A
N/A	Landing Slope (%)	N/A	N/A	DWS Length (in)	N/A
N/A	Landing X Slope (%)	N/A	N/A	DWS Full Width?	N/A
N/A	Landing Curb? (Y/N)	N/A	N/A	DWS Offset (in)	N/A
N/A	Shared Landing?	N/A			
N/A	Gutter Ponding?	N/A	N/A	Gutter Slope (%)	N/A
N/A	Gutter Lip Ht (in)	N/A	N/A	Gutter X Slope (%)	N/A
N/A	Painted X Walk1?	Yes	N/A	Painted X Walk2?	Yes
	X Walk 1 Direction	To SW		X Walk 2 Direction	To SE
N/A	X Walk 1 Width (in)	110.0	N/A	X Walk 2 Width (in)	111.0
	X Walk 1 Slope (%)	2.8		X Walk 2 Slope (%)	5.2
	X Walk 1 X Slope (%)	2.8		X Walk 2 X Slope (%)	3.9

N/A	Ramp inside XWalk1?	Yes	N/A	Ramp inside XWalk2?	No
	Road Slope (%)	4.6	N/A	Clear Space?	N/A
	Road X Slope (%)	2.8	N/A	Clear Space to XWalk (in)	N/A
N/A	Any Obstructions?	N/A	N/A	Storm Grate/Utility Hazard?	N/A
	Obstruction Type			Storm Grate/Utility Type	
		N/A			N/A
		Yes		Surface Condition? (G/P)	Good

Remove & Replace Curb Ramp With Two New Directional Ramps or Equivalent. Restripe Crosswalk.
