Access Compliance Report

Public Rights-of-Way

(Curb Ramps)

Intersection ID: 18787	Main Street: MONROE_RD	Cross Street: WOODBERRY_RD	Location: SW
ADA ID: 76E84C7F2BCD	Ramp Type: PerpDiag	Initial Pass/Fail: Fail	Overall Compliance: No
		Severity Score: 12.5

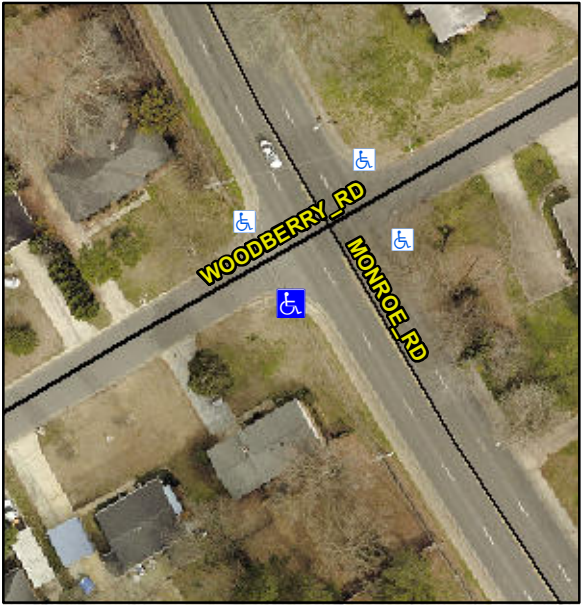
Possible Solutions:		Compliance	Description	Data	
	Remove & Replace Curb Ramp With Two New Directional Ramps or Equivalent.		No	Ramp Length (in)	60.0	Ramp Slope (%)
			Yes	Ramp Width (in)	48.0	Ramp XSlope (%)
			N/A	Flare Type LT	N/A	Flare Type RT
			N/A	Flare Slope LT (%)	N/A	Flare Slope RT (%)
			N/A	Flare Traversable LT?	N/A	Flare Traversable RT?
			N/A	Landing Length (in)	N/A	DWS Provided?
			N/A	Landing Width (in)	N/A	DWS Contrast?
			N/A	Landing Slope (%)	N/A	DWS Length (in)
			N/A	Landing X Slope (%)	N/A	DWS Full Width?
			N/A	Landing Curb? (Y/N)	N/A	DWS Offset (in)
			N/A	Shared Landing?	N/A	
			N/A	Gutter Ponding?	N/A	Gutter Slope (%)
			N/A	Gutter Lip Ht (in)	N/A	Gutter X Slope (%)
			N/A	Painted X Walk1?	No	Painted X Walk2?
				X Walk 1 Direction	To E	X Walk 2 Direction
			N/A	X Walk 1 Width (in)	N/A	X Walk 2 Width (in)

X Walk 1 Slope (%)	3.3	X Walk 2 Slope (%)
				X Walk 1 X Slope (%)	2.7	X Walk 2 X Slope (%)
			N/A	Ramp inside XWalk1?	N/A	Ramp inside XWalk2?
				Road Slope (%)	1.5	Clear Space?
				Road X Slope (%)	4.3	Clear Space to XWalk (in)
			N/A	Any Obstructions?	N/A	Storm Grate/Utility Hazard?
				Obstruction Type		Storm Grate/Utility Type
			N/A			N/A
			Yes	Surface Condition? (G/P)		Good

Not Found, R304.2.2

Remove & Replace Curb Ramp With Two New Directional Ramps or Equivalent.
