Access Compliance Report

Public Rights-of-Way

(Curb Ramps)

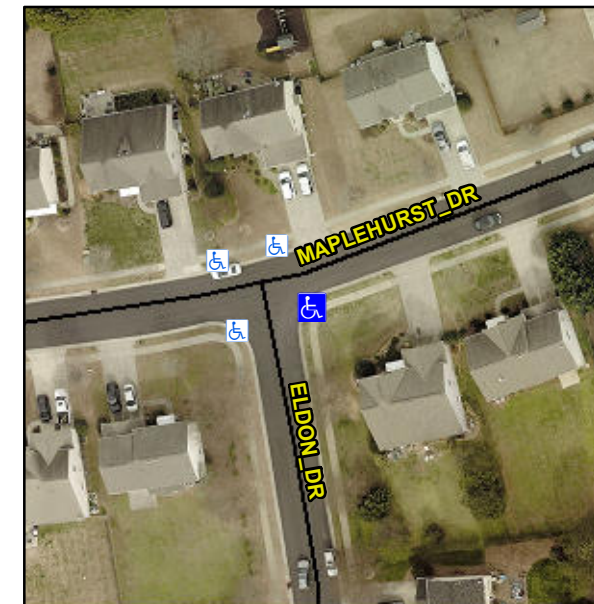
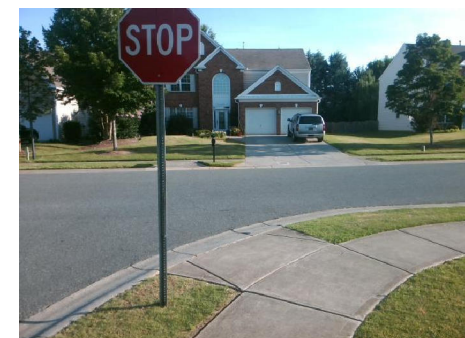
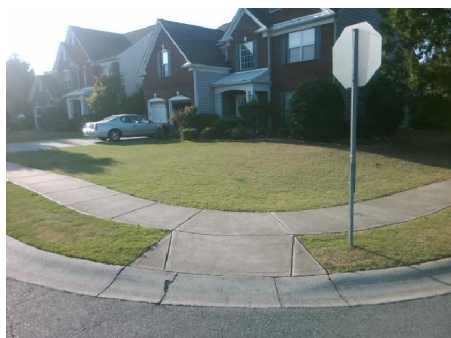
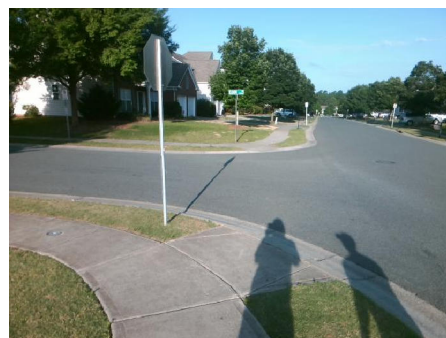
Intersection ID: 45179	Main Street: ELDON_DR	Cross Street: MAPLEHURST_DR	Location: SE
ADA ID: 76F02A4CB10D	Ramp Type: BlendTrans1	Initial Pass/Fail: Fail	Overall Compliance: No
Severity Score: 12.5			
Codes/Mitigation Info/Possible Solution		Field Measurements/Component Compliance

PROW/ADA:

Not Found, R304.5.3

Compliance	Description	Data	Compliance	Description	Data
N/A	Ramp Length (in)	48.0	Yes	BlendTrans Slope (%)	4.9
Yes	Ramp Width (in)	58.0	No	BlendTrans XSlope (%)	6.2
N/A	Flare Type LT	N/A	N/A	Flare Type RT	N/A
N/A	Flare Slope LT (%)	N/A	N/A	Flare Slope RT (%)	N/A
N/A	Flare Traversable LT?	N/A	N/A	Flare Traversable RT?	N/A
N/A	Landing Length (in)	N/A	N/A	DWS Provided?	N/A
N/A	Landing Width (in)	N/A	N/A	DWS Contrast?	N/A
N/A	Landing Slope (%)	N/A	N/A	DWS Length (in)	N/A
N/A	Landing X Slope (%)	N/A	N/A	DWS Full Width?	N/A
N/A	Landing Curb? (Y/N)	N/A	N/A	DWS Offset (in)	N/A
N/A	Shared Landing?	N/A			
N/A	Gutter Ponding?	N/A	N/A	Gutter Slope (%)	N/A
N/A	Gutter Lip Ht (in)	N/A	N/A	Gutter X Slope (%)	N/A
N/A	Painted X Walk1?	No	N/A	Painted X Walk2?	No
	X Walk 1 Direction	To NW		X Walk 2 Direction	To SW
	X Walk 1 Width (in)	N/A		X Walk 2 Width (in)	N/A
	X Walk 1 Slope (%)	3.8		X Walk 2 Slope (%)	0.1
	X Walk 1 X Slope (%)	1.7		X Walk 2 X Slope (%)	4.2

N/A	Ramp inside XWalk1?	N/A	N/A	Ramp inside XWalk2?	N/A
	Road Slope (%)	3.2		Clear Space?	N/A
	Road X Slope (%)	2.8	N/A	Clear Space to XWalk (in)	N/A
N/A	Any Obstructions?	N/A	N/A	Storm Grate/Utility Hazard?	N/A
	Obstruction Type			Storm Grate/Utility Type	
		N/A			N/A
			Yes	Surface Condition? (G/P)	Good
			No	Curb Slope (%)	12.0

Possible Solutions:

Remove & Replace Curb Ramp With Two New Directional Ramps or Equivalent.
