## Access Compliance Report Public Rights-of-Way (Curb Ramps)

`			,					
Intersection ID: 45778	Main Street: CARVER_FALLS_RD				Cross Street: WINDING_RIVER_DR				Location:	NW
ADA ID: 76F58B166279	Ramp Ty	Ramp Type: Perp			Initial Pass/Fail: Pass Overall Compliance: No				o Severity Score:	7.5
Codes/Mitigation Info/Possible Solution					Field Measurements/Component Compliance					
		Possible Solutions:			Compliance Description			Data Compliance Description		
		Remove & Replace Enti	re Ran	מו.	N/A	Ramp Length (in)	71.0	Yes	Ramp Slope (%)	5.3
	LAX Y	Remove & Replace Gut		-P-	Yes	Ramp Width (in)	48.0	Yes	Ramp XSlope (%)	0.3
	10211	-			N/A	Flare Type LT	Sloped	N/A	Flare Type RT	N/A
	REP IM				N/A	Flare Slope LT (%)	4.0	Yes	Flare Slope RT (%)	7.4
	A CAR				N/A	Flare Traversable LT?	Yes	N/A	Flare Traversable RT?	Yes
	A MER DE				Yes	Landing Length (in)	49.0	Yes	DWS Provided?	Yes
1-121-1	H & me	Surveyor Notes:			Yes	Landing Width (in)	53.0	Yes	DWS Contrast?	Yes
	E VILLE	N/A			No	Landing Slope (%)	2.2	Yes	DWS Length (in)	24.0

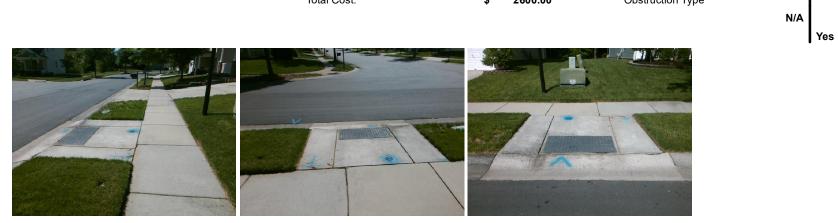
The states	E A NO				Yes	Landing X Slope (%)	1.2	No	DWS Full Width?	No
				N/A	Landing Curb? (Y/N)	No	Yes	DWS Offset (in)	1.0	
				N/A	Shared Landing?	No				
	AFT THE A	PROW/ADA:			Yes	Gutter Ponding?	No	No	Gutter Slope (%)	5.6
and the second		Not Found, R304.2.2-Pe	rp, R30	04.3.2-	Yes	Gutter Lip Ht (in)	0.0	Yes	Gutter X Slope (%)	1.6
A TAN	6 . I I Katolog	Para, R305.1.4, R304.5.4			N/A	Painted X Walk1?	No	N/A	Painted X Walk2?	N/A
Carlo Bat Lan					X Walk 1 Direction	To E		X Walk 2 Direction	N/A	
A SUL - and a				N/A	X Walk 1 Width (in)	N/A	N/A	X Walk 2 Width (in)	N/A	
Street 1 Name	CARVER FALLS RD					X Walk 1 Slope (%)	3.9		X Walk 2 Slope (%)	N/A
Stop Condition-Street 2	None					X Walk 1 X Slope (%)	0.7		X Walk 2 X Slope (%)	N/A
Street 2 Name	N/A				N/A	Ramp inside XWalk1?	N/A	N/A	Ramp inside XWalk2?	N/A
Stop Condition-Street 1	N/A					Road Slope (%)	N/A	N/A	Clear Space?	Yes
						Road X Slope (%)	N/A	N/A	Clear Space to XWalk (in)	N/A

Yes	Any Obstructions?	No	Yes	Storm Grate/Utility Hazard?	No
		Total Cost:	\$	2600.00		Obstruction Type			Storm Grate/Utility Type	
							N/A			N/A
								•

s Surface Condition? (G/P) Good
