Access Compliance Report

Public Rights-of-Way

(Curb Ramps)

Intersection ID: 9172	Main Street: E_CRAIGHEAD_RD	Cross Street: N_TRYON_ST	Location:	S
ADA ID: 76FEAD854FCC	Ramp Type: Perp	Initial Pass/Fail: Fail	Overall Compliance: No	Severity Score: 22.5
Codes/Mitigation Info/Possible Solution		Field Measurements/Component Compliance

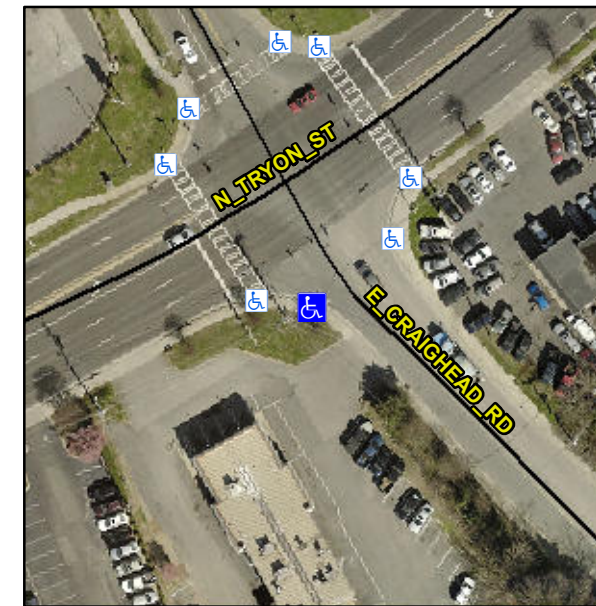
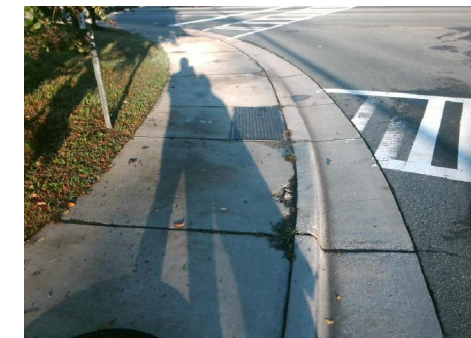
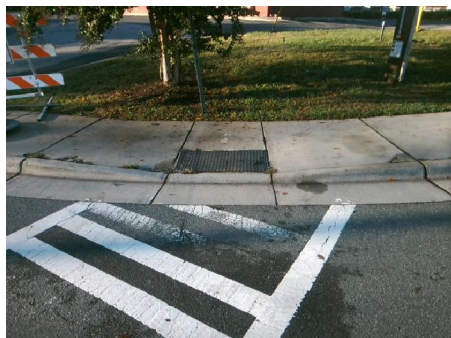
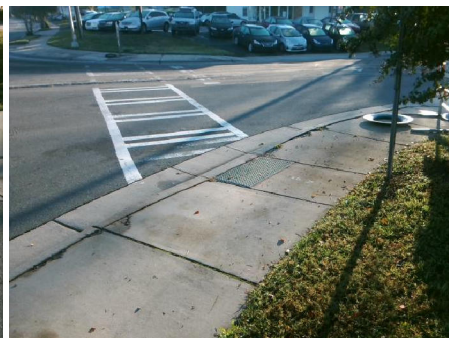
Not Found, R304.5.1, R304.2.2, R304.5.3

Compliance	Description	Data	Compliance	Description	Data
N/A	Ramp Length (in)	71.5	No	Ramp Slope (%)	9.3
No	Ramp Width (in)	44.0	No	Ramp XSlope (%)	3.1
N/A	Flare Type LT	N/A	N/A	Flare Type RT	N/A
N/A	Flare Slope LT (%)	N/A	N/A	Flare Slope RT (%)	N/A
N/A	Flare Traversable LT?	N/A	N/A	Flare Traversable RT?	N/A
N/A	Landing Length (in)	N/A	N/A	DWS Provided?	N/A
N/A	Landing Width (in)	N/A	N/A	DWS Contrast?	N/A
N/A	Landing Slope (%)	N/A	N/A	DWS Length (in)	N/A
N/A	Landing X Slope (%)	N/A	N/A	DWS Full Width?	N/A
N/A	Landing Curb? (Y/N)	N/A	N/A	DWS Offset (in)	N/A
N/A	Shared Landing?	N/A			
N/A	Gutter Ponding?	N/A	N/A	Gutter Slope (%)	N/A
N/A	Gutter Lip Ht (in)	N/A	N/A	Gutter X Slope (%)	N/A
N/A	Painted X Walk1?	Yes	N/A	Painted X Walk2?	N/A
	X Walk 1 Direction	To NE		X Walk 2 Direction	N/A
N/A	X Walk 1 Width (in)	81.5	N/A	X Walk 2 Width (in)	N/A
	X Walk 1 Slope (%)	0.2		X Walk 2 Slope (%)	N/A
	X Walk 1 X Slope (%)	2.7		X Walk 2 X Slope (%)	N/A

N/A	Ramp inside XWalk1?	Yes	N/A	Ramp inside XWalk2?	N/A
	Road Slope (%)	N/A	N/A	Clear Space?	N/A
	Road X Slope (%)	N/A	N/A	Clear Space to XWalk (in)	N/A
N/A	Any Obstructions?	N/A	N/A	Storm Grate/Utility Hazard?	N/A
	Obstruction Type			Storm Grate/Utility Type	
		N/A			N/A
		Yes		Surface Condition? (G/P)	Good

Remove & Replace Entire Ramp.

Total Cost: \$ 1850.00
