N/A

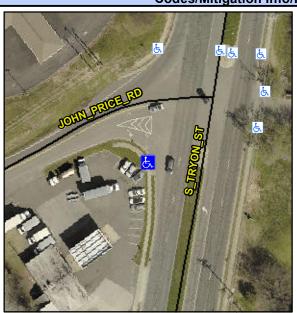
Codes/Mitigation Info/Possible Solution

Street 1 Name	S TRYON ST
Stop Condition-Street 2	None
Street 2 Name	N/A
Stop Condition-Street 1	N/A
