Access Compliance Report Public Rights-of-Way (Curb Ramps)

Intersection ID: 14235	Main Street: CAMDEN_RD			Cross Street: E_TREMONT_AV				Location:	NW
ADA ID: 771BF3AFAA4A	Ramp Ty	Ramp Type: Perp			il: Fail Overall (ice: N	o Severity Score:	12.5	
Codes/Mitigation Info/Possible Solution			Field Measurements/Component Compliance						
in the second second	¢ / 6	Possible Solutions:	Compliance Description		iance Description	Data Compliance		liance Description	Data
	18/201	Remove & Replace Entire Ramp	. N	/A	Ramp Length (in)	108.0	No	Ramp Slope (%)	9.0
1				es	Ramp Width (in)	48.0	Yes	Ramp XSlope (%)	2.0

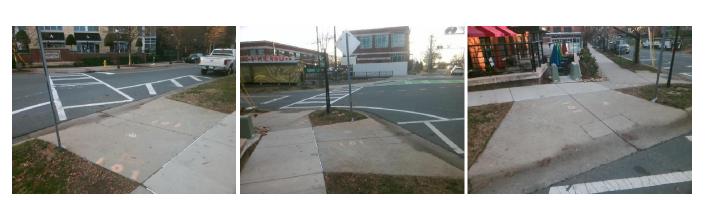
17. · · · · · · · ·			N	/ A	Flare Type LT	N/A	N/A	Flare Type RT	N/A
and the second states		8	N	/ A	Flare Slope LT (%)	N/A	N/A	Flare Slope RT (%)	N/A
A DE THE			N	/ A	Flare Traversable LT?	N/A	N/A	Flare Traversable RT?	N/A
	10 340		N	/ A	Landing Length (in)	N/A	N/A	DWS Provided?	N/A
the second secon	X ZX	Surveyor Notes:	N	/ A	Landing Width (in)	N/A	N/A	DWS Contrast?	N/A
		N/A	N	/ A	Landing Slope (%)	N/A	N/A	DWS Length (in)	N/A
W_TREMONT_AV	5. // 6. / 6.		N	/ A	Landing X Slope (%)	N/A	N/A	DWS Full Width?	N/A
5 1 1 1 1 1 1 1 1 1 1 1 1 1 1 1 1 1 1 1	<u>6.</u>		N	/ A	Landing Curb? (Y/N)	N/A	N/A	DWS Offset (in)	N/A
6	8		N	/ A	Shared Landing?	N/A			
The second secon	No.	PROW/ADA:	N	/ A	Gutter Ponding?	N/A	N/A	Gutter Slope (%)	N/A
I still and the second states of the	A CONSTRUCTION	R304.2.2	N	/ A	Gutter Lip Ht (in)	N/A	N/A	Gutter X Slope (%)	N/A
A REAL PROPERTY AND	6. 6		N	/ A	Painted X Walk1?	Yes	N/A	Painted X Walk2?	N/A

1 1 1 1 1 1 1 1 1 1 1 1 1 1 1 1 1 1 1	A				X Walk 1 Direction	To SW		X Walk 2 Direction	N/A
AND AND AND AND			N	/ A	X Walk 1 Width (in)	103.0	N/A	X Walk 2 Width (in)	N/A
Street 1 Name	V TREMONT AV	-			X Walk 1 Slope (%)	8.0		X Walk 2 Slope (%)	N/A
Stop Condition-Street 2	None				X Walk 1 X Slope (%)	2.4		X Walk 2 X Slope (%)	N/A
Street 2 Name	N/A		N	/ A	Ramp inside XWalk1?	Yes	N/A	Ramp inside XWalk2?	N/A
Stop Condition-Street 1	N/A				Road Slope (%)	N/A	N/A	Clear Space?	N/A
					Road X Slope (%)	N/A	N/A	Clear Space to XWalk (in)	N/A
			Ν	/ A	Any Obstructions?	N/A	N/A	Storm Grate/Utility Hazard?	N/A
		Total Cost: \$	850.00		Obstruction Type			Storm Grate/Utility Type	
						N/A			N/A
